Reservoir 1 *North Tank*

Report of Findings

Underwater Inspection of Reservoir 1

November 6, 2015

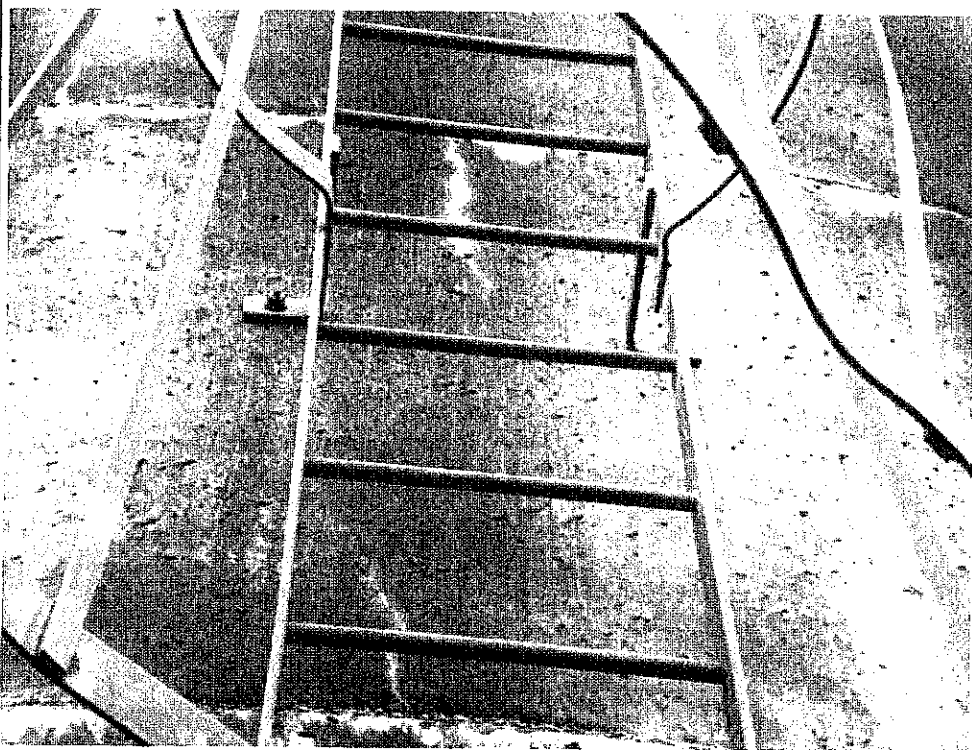
Image #1

Exterior Ladder 12:05

Condition:
Rust Grade 8.

Description:
Exterior Ladder
appeared to be in good
condition with a minor
amount of corrosion.

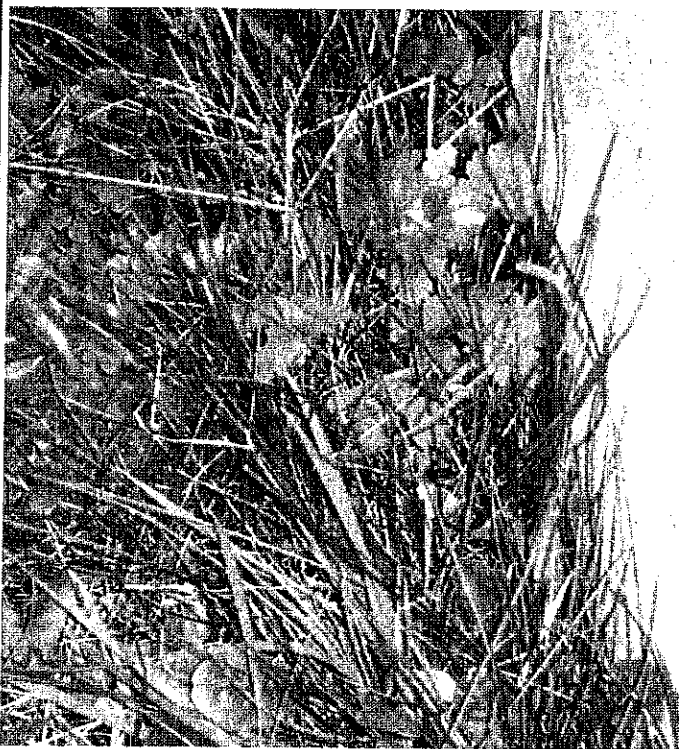
Image #2

*Exterior Earthen Base
3:00*

Description:
Exterior Earthen Base
appeared to be in good
condition with no
problems.

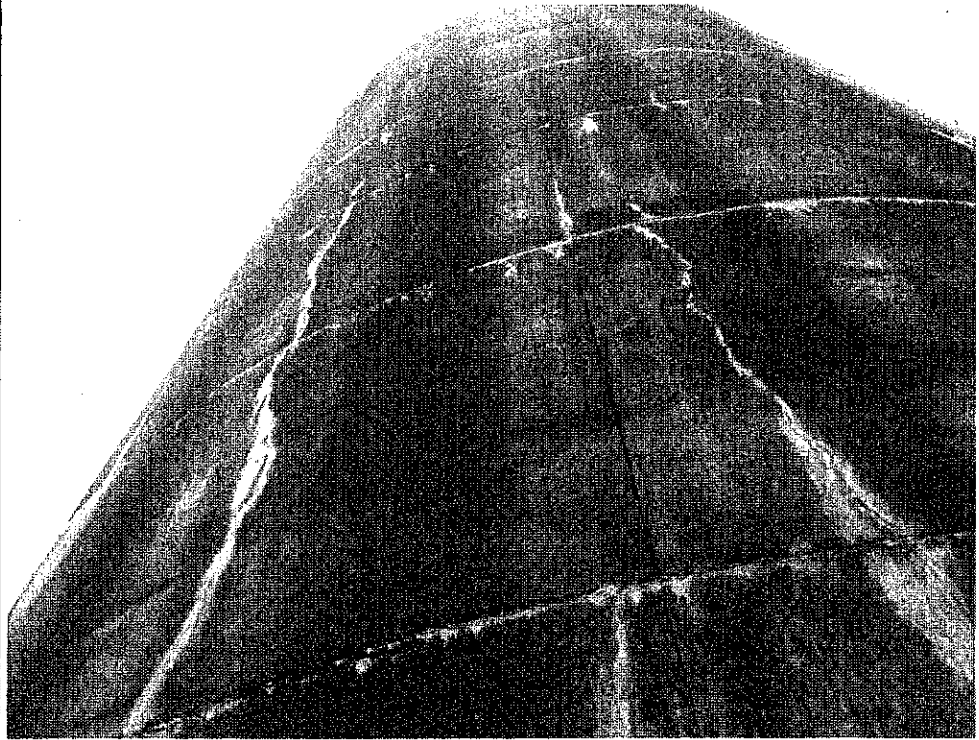
Image #3

Exterior Wall 3:00

Condition:
Concrete Deform³ CK

Description:
Exterior Wall
appeared to be in fair
condition with a
moderate amount of
cracking.

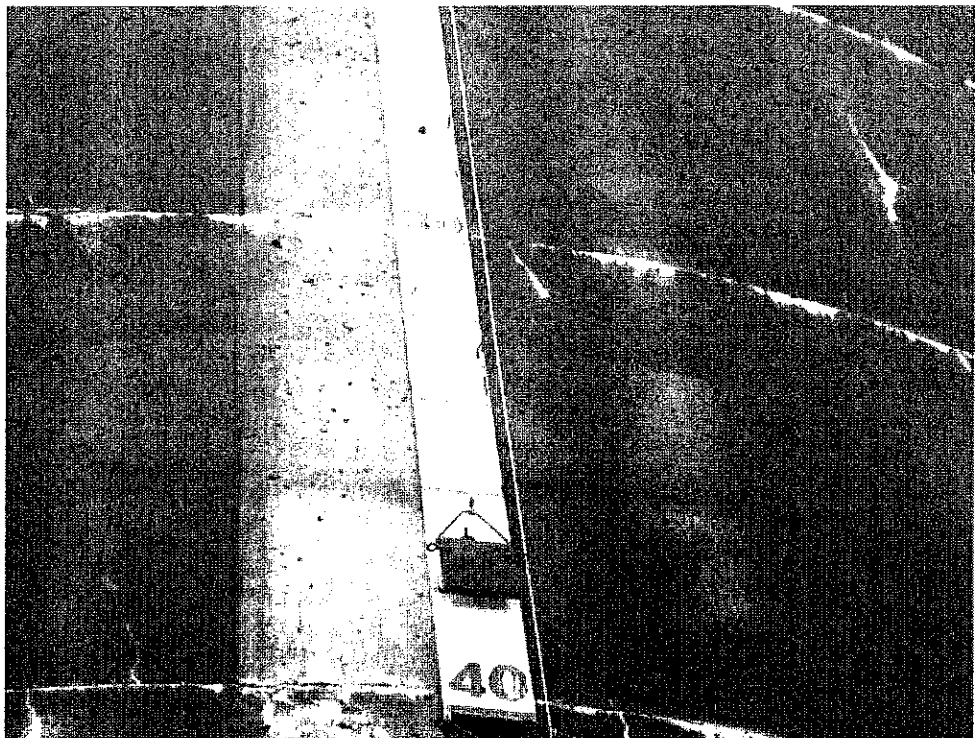
Image #4

*Liquid Level Indicator
Reader Board 5:00*

Condition:
Rust Grade¹ 4

Description:
Liquid Level Indicator
Reader Board appeared
to be in fair condition
with a moderate
amount of corrosion
and a heavy amount of
rot.

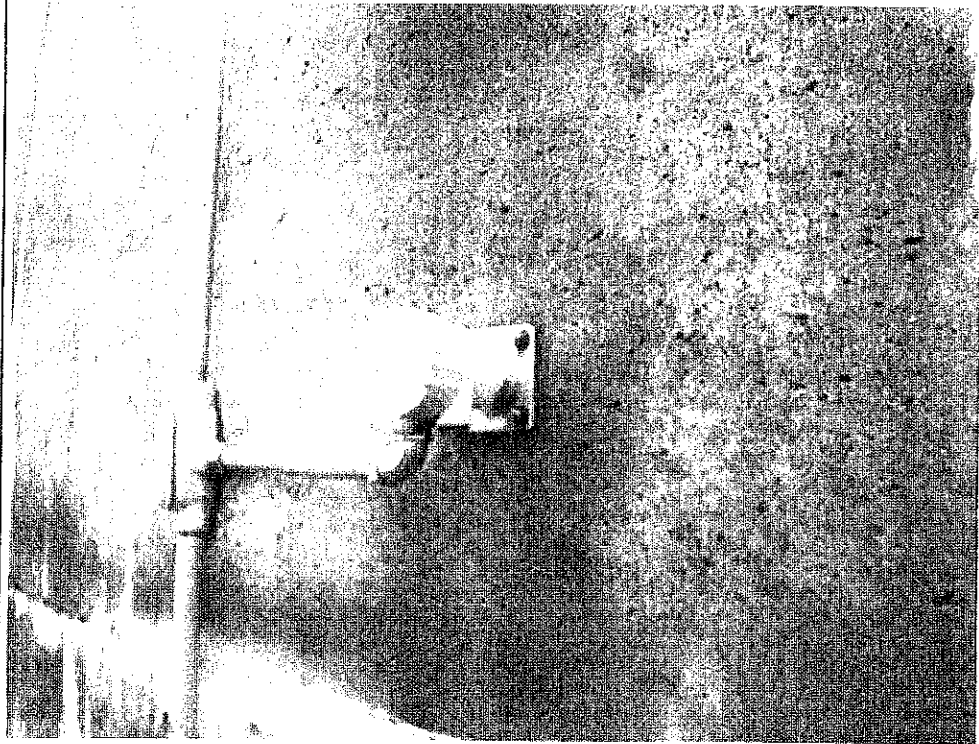
Image #5

Telemetry 5:30

Condition:
Rust Grade¹ 9.

Description:
1 1/2" Telemetry
appeared to be in good
condition with a minor
amount of corrosion.

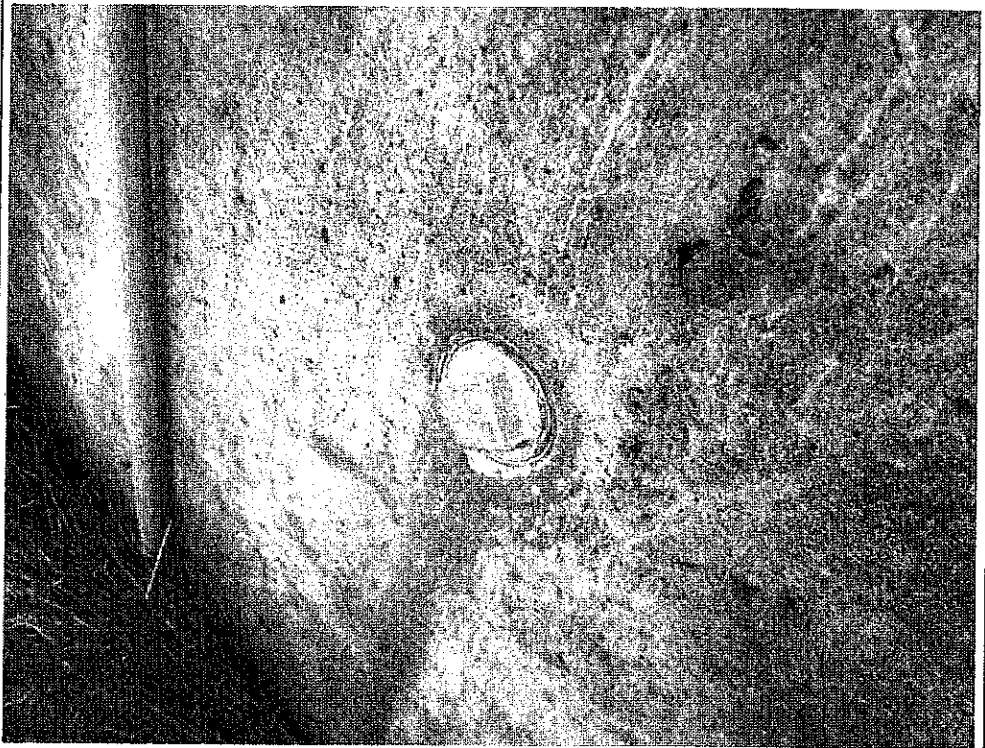
Image #6

Capped Off Penetration
5:45

Condition:
Rust Grade¹ 7.

Description:
3" Capped Off
Penetration appeared to
be in fair condition
with a minor amount of
corrosion.

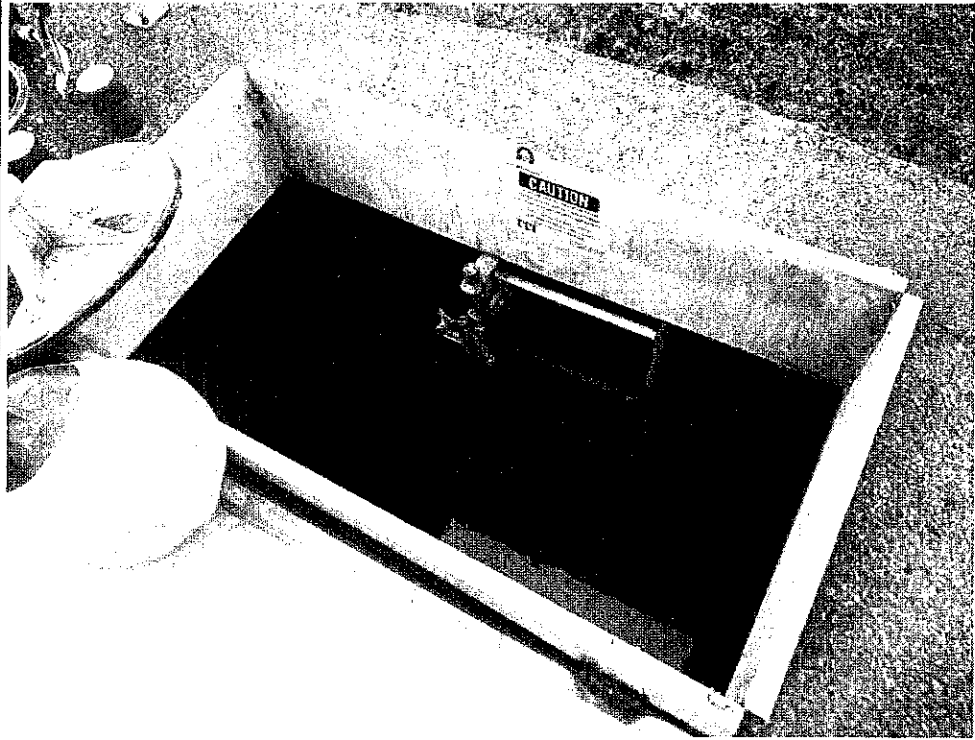
Image #7

Entry Hatch 12:00

Condition:
Rust Grade¹ 6.

Description:
24"x48" Entry Hatch appeared to be in fair condition with a moderate amount of corrosion.

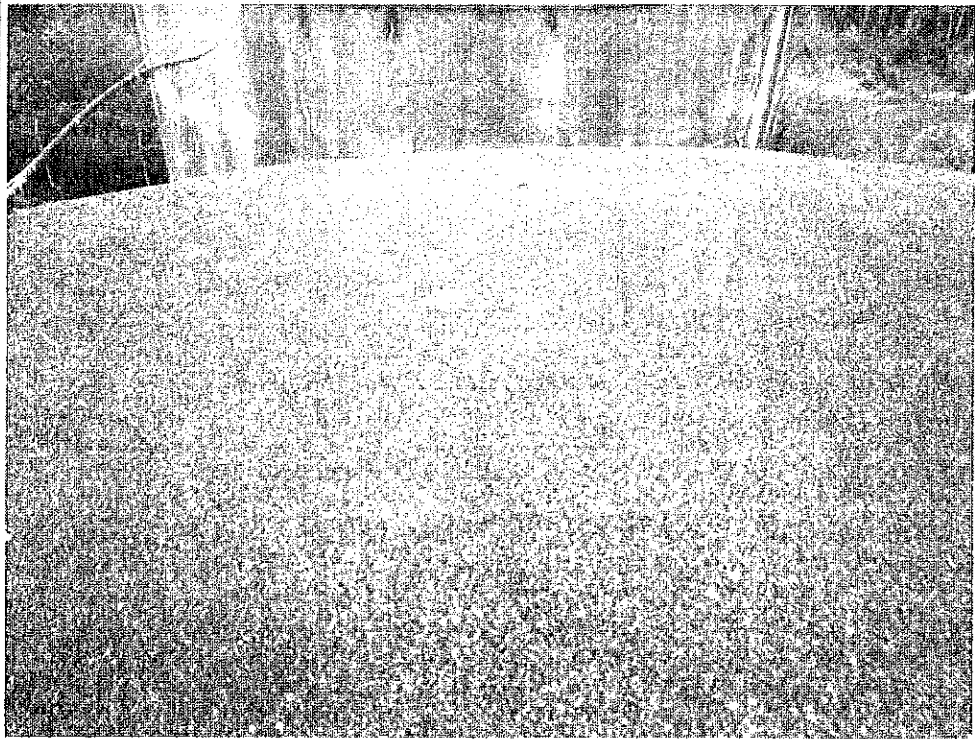
Image #8

Roof 3:00

Condition:
Concrete Deform³ GC.

Description:
Roof appeared to be in good condition with no concrete problems.

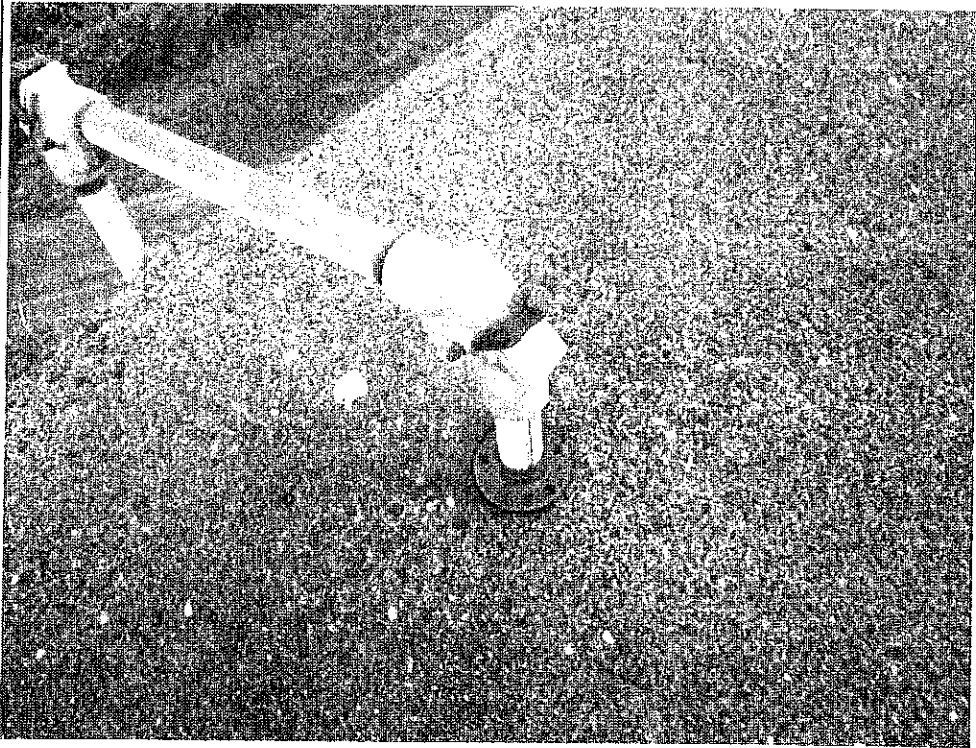
Image #9

*Liquid Level Indicator
Penetration 5:00*

Condition:
Rust Grade¹ 2.

Description:
1 1/2" Liquid Level
Indicator Penetration
appeared to be in fair
condition with a
moderate amount of
corrosion.

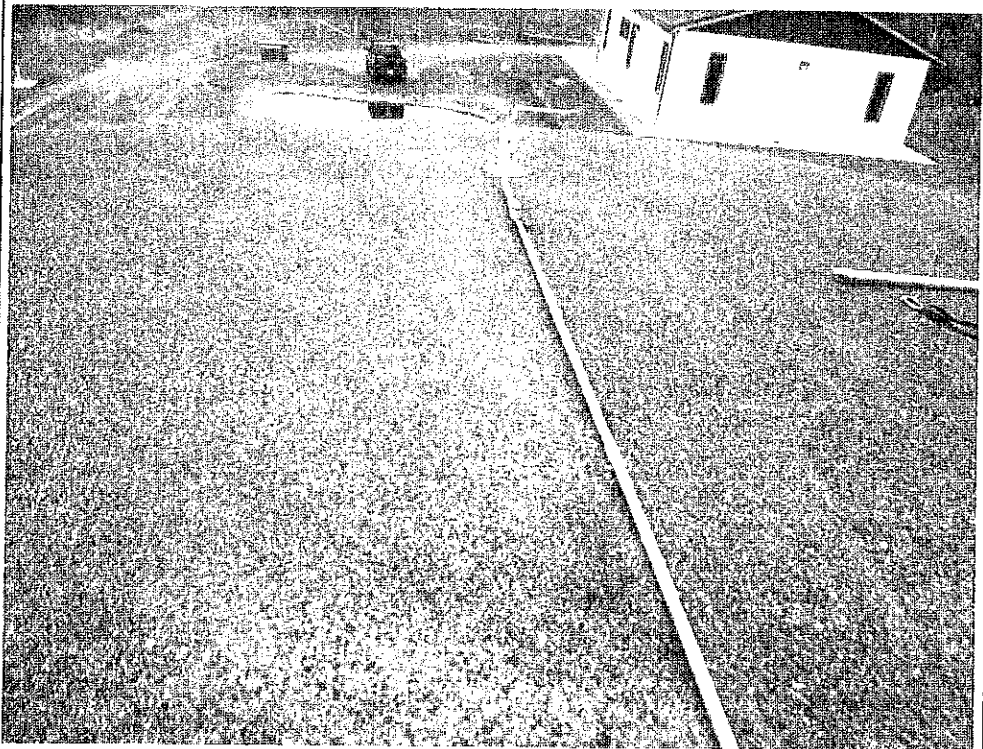
Image #10

Roof 9:00

Condition:
Concrete Deform³ GC.

Description:
Roof appeared to be in
good condition with no
concrete problems.

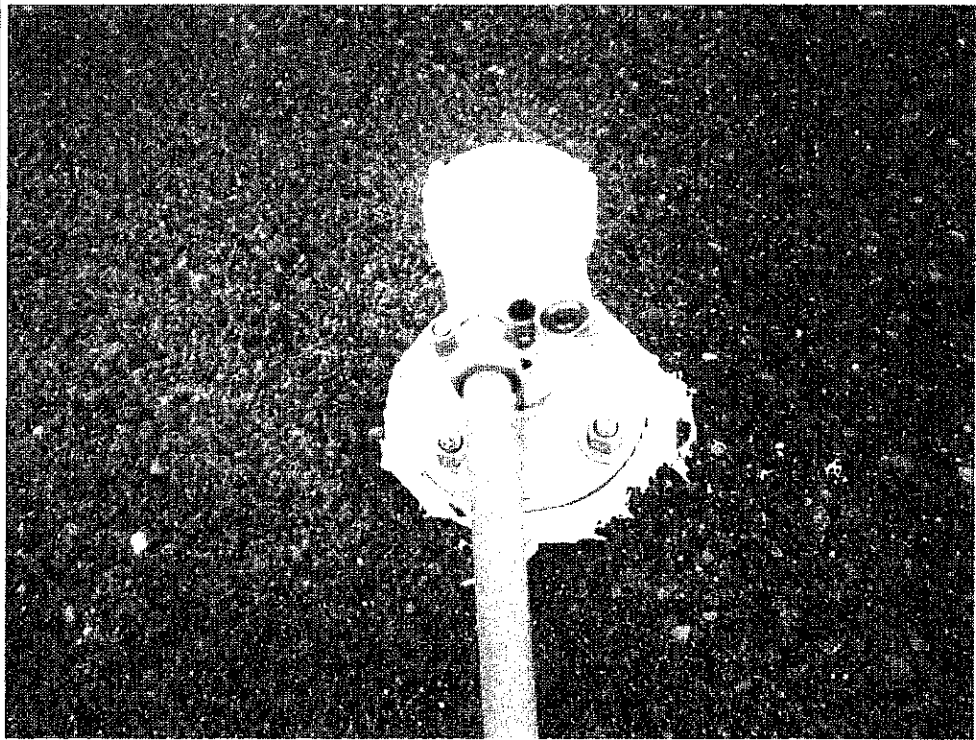
Image #11

Telemetry Penetration
9:00

Condition:
Rust Grade¹ 9.

Description:
1" Telemetry
Penetration appeared to
be in good condition
with a minor amount of
corrosion.

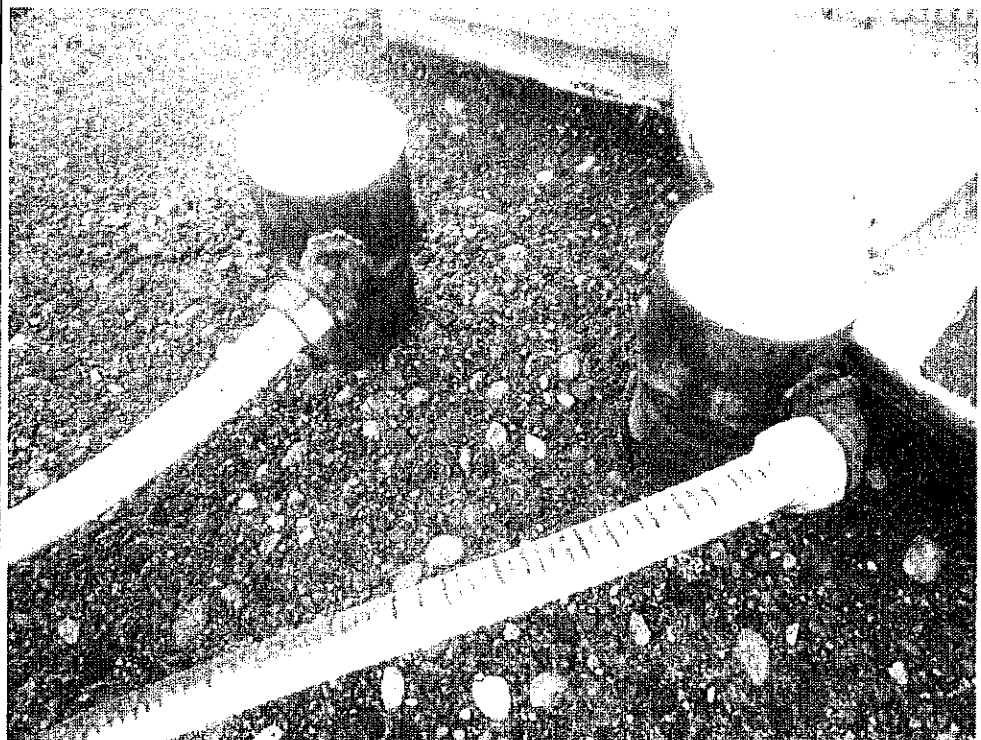
Image #12

Telemetry Penetrations
11:55

Condition:
Rust Grade¹ 1.

Description:
2" Telemetry
Penetrations appeared
to be in fair condition
with a moderate
amount of corrosion.

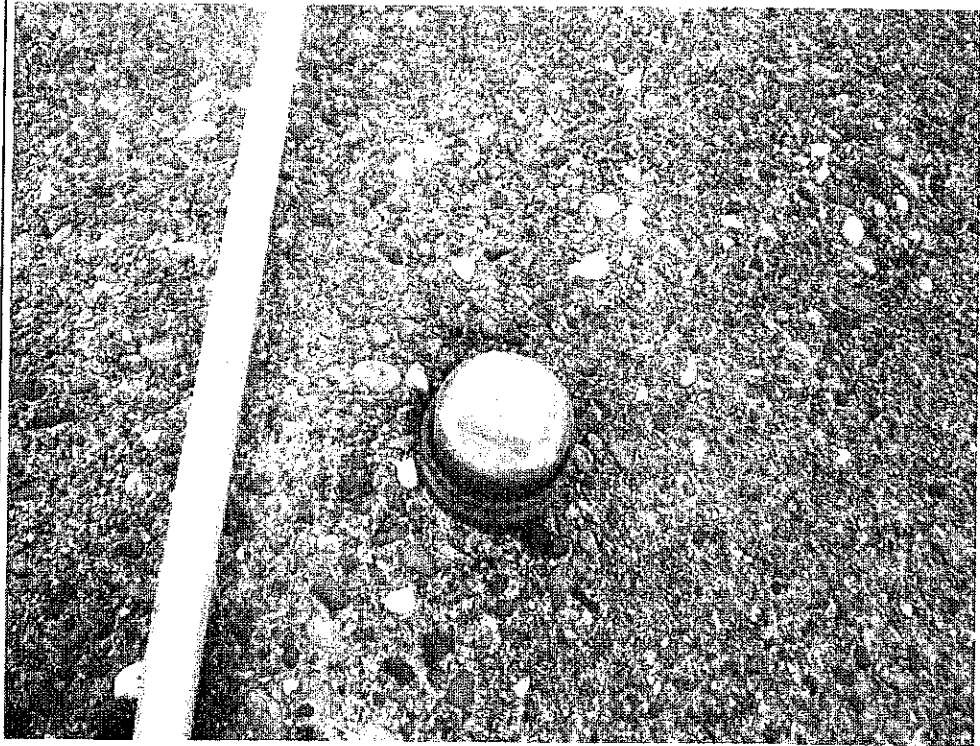
Image #13

*Capped Off Penetration
Center*

Condition:
Rust Grade¹ 2.

Description:
2" Capped Off
Penetration appeared to
be in fair condition
with a moderate
amount of corrosion.

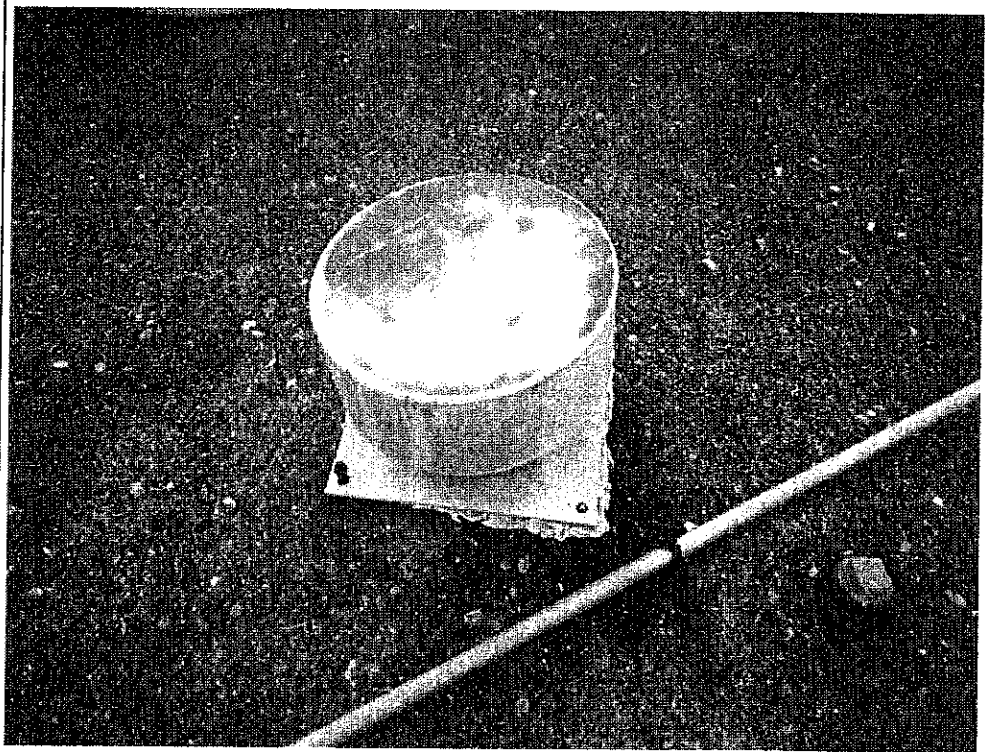
Image #14

Vent Center

Condition:
Rust Grade¹ 3.

Description:
8" Vent appeared to be
in good condition with
a minor amount of
corrosion.

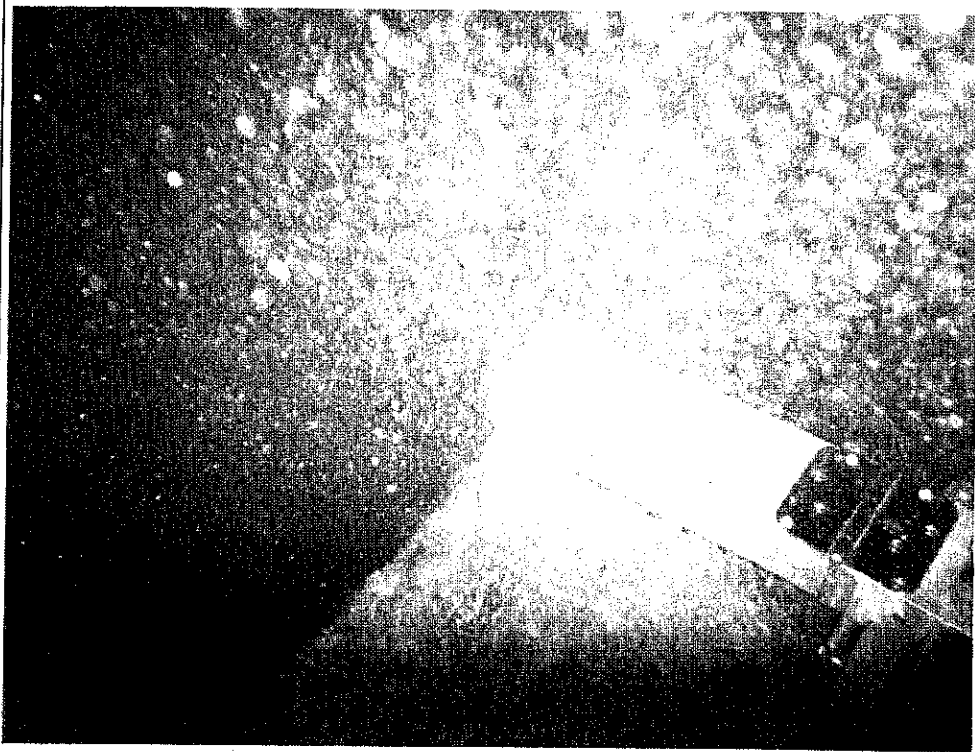
Image #17

Sediment

Description:
3/4" of sediment was
removed from
reservoir floor.

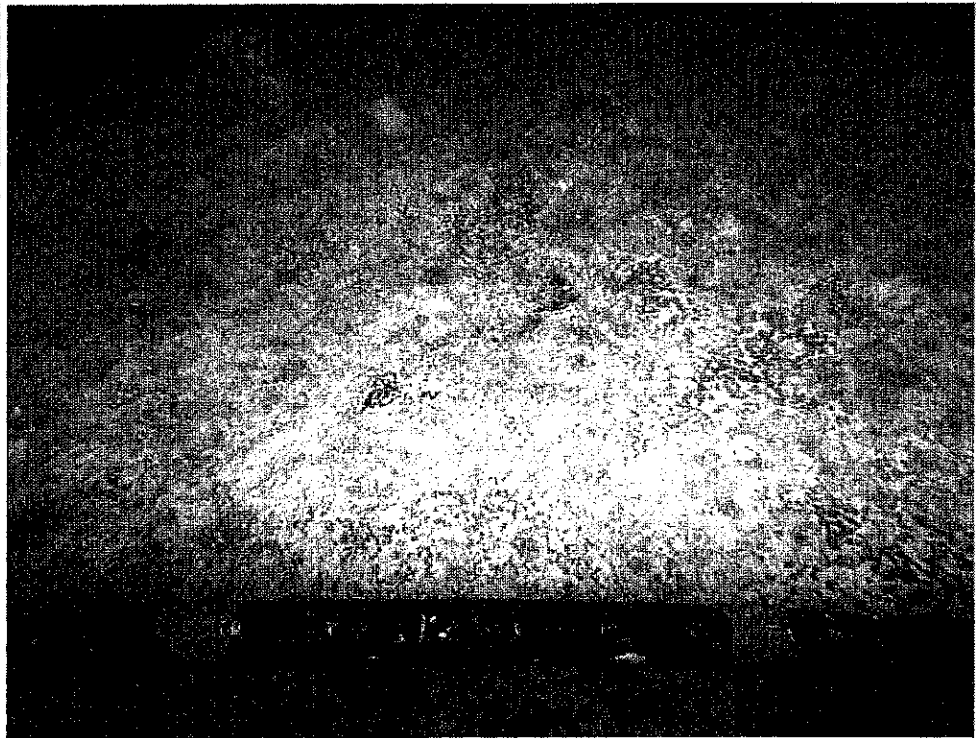
Image #19

Floor 12:00

Condition:
Concrete Deform³ GC

Floor appeared to be in good condition with no concrete problems.

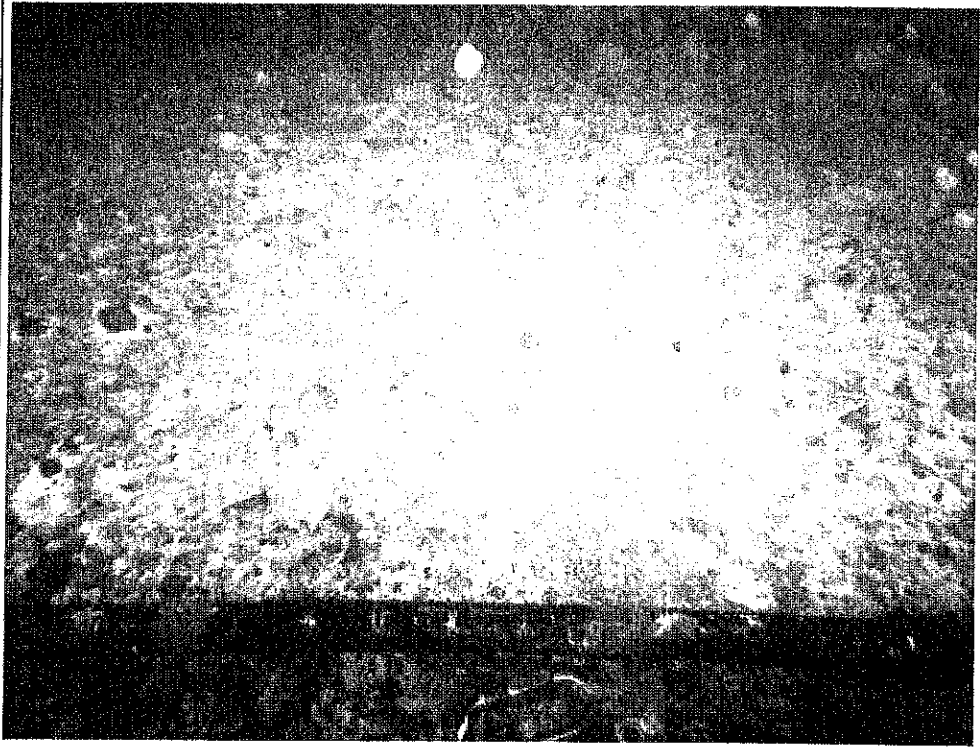
Image #21

Floor 3:00

Condition:
Concrete Deform³ GC.

Description:
Floor appeared to be
in good condition with
no concrete problems.

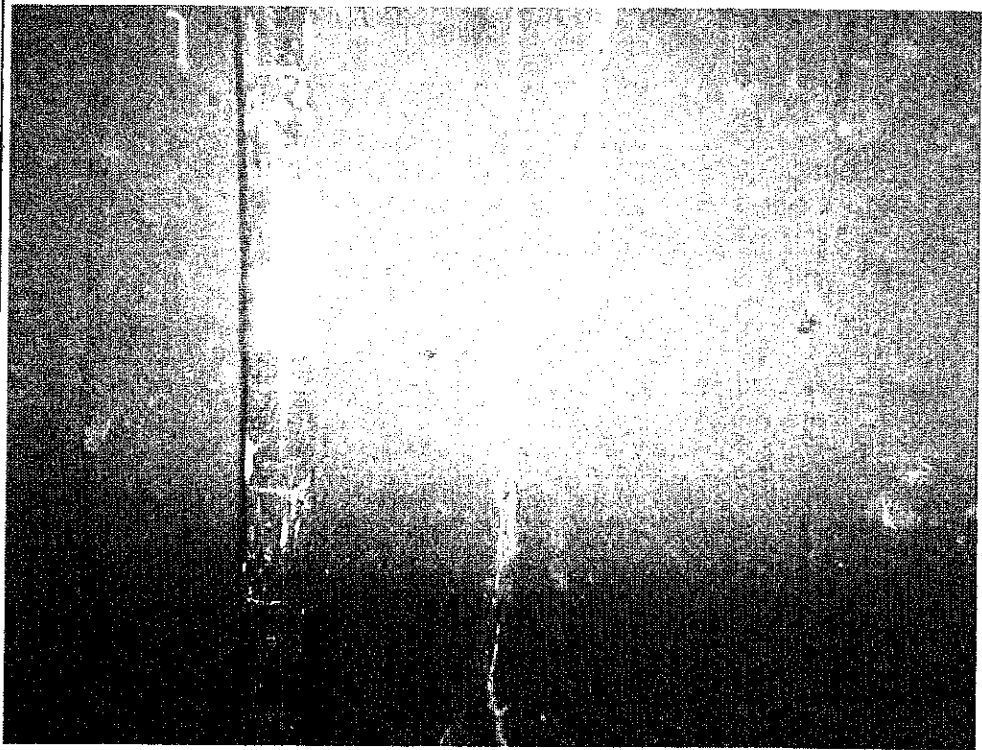
Image #22

Wall 3:00

Condition:
Concrete Deform³ CK,
PO.

Description:
Wall appeared to be in
good condition with a
minor amount of
cracking and popouts.

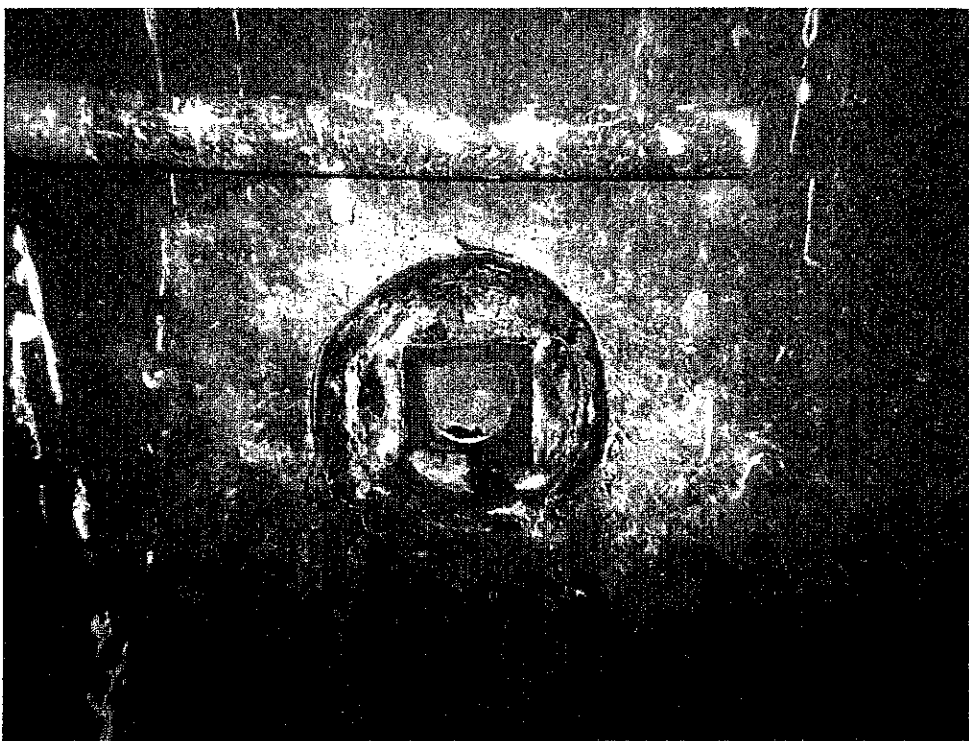
Image #24

Capped Off Penetration
5:45

Condition:
Rust Grade¹ 1.

Description:
3" Capped Off
Penetration appeared to
be in poor condition
with a heavy amount of
corrosion.

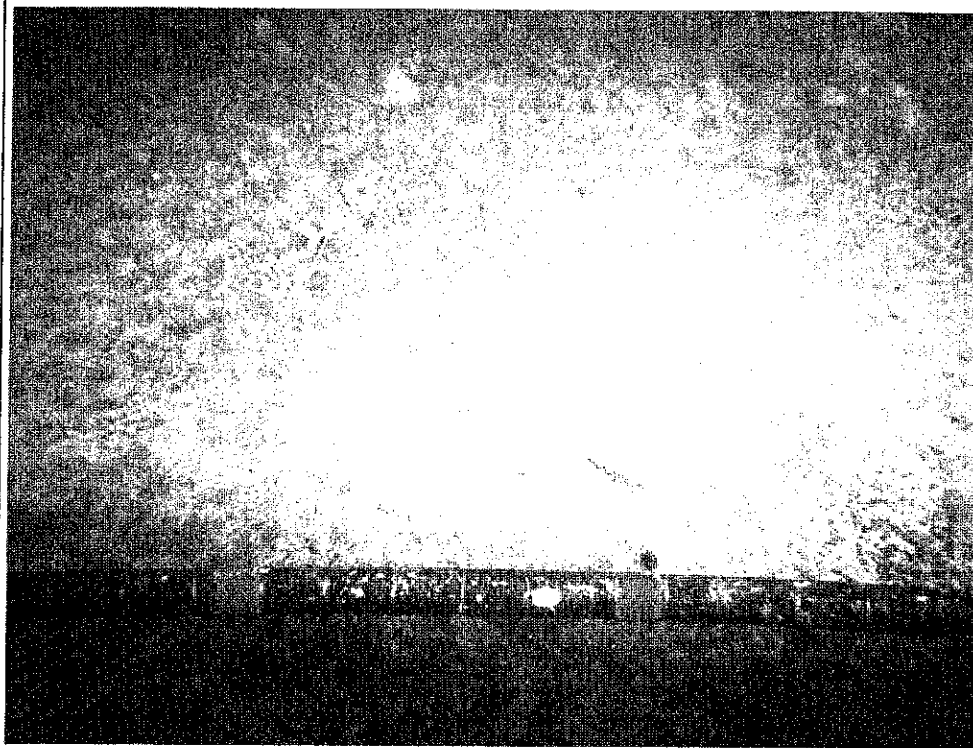
Image #25

Floor 6:00

Condition:
Concrete Deform³ GC.

Description:
Floor appeared to be
in good condition with
no concrete problems.

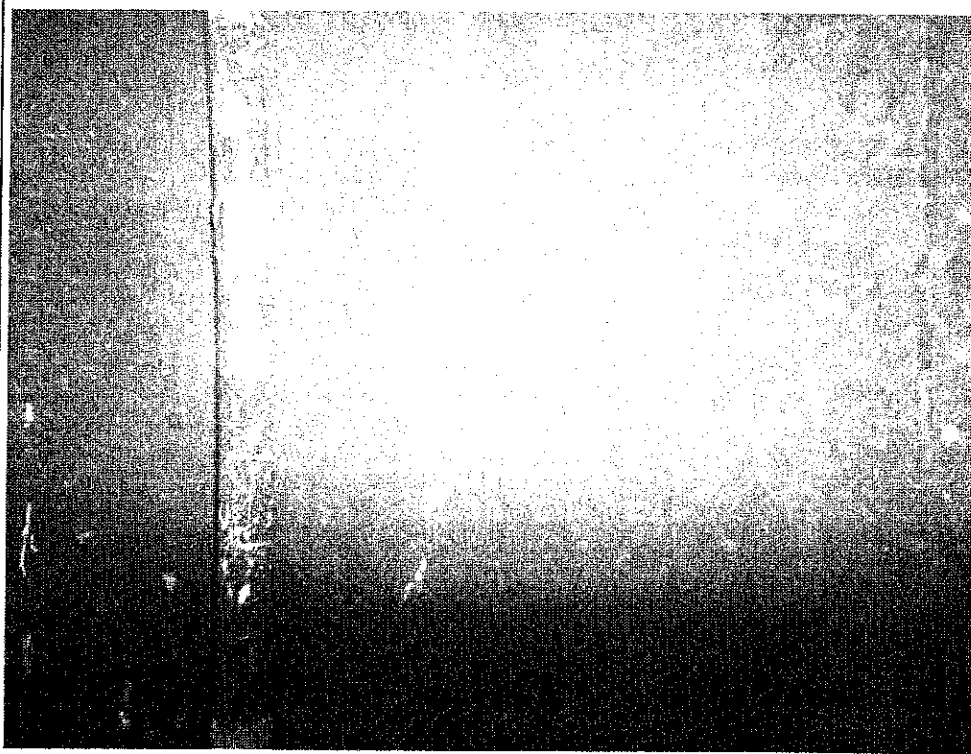
Image #26

Wall 6:00

Condition:
Concrete Deform³ CK,
PO.

Description:
Wall appeared to be in
good condition with a
minor amount of
cracking and popouts.

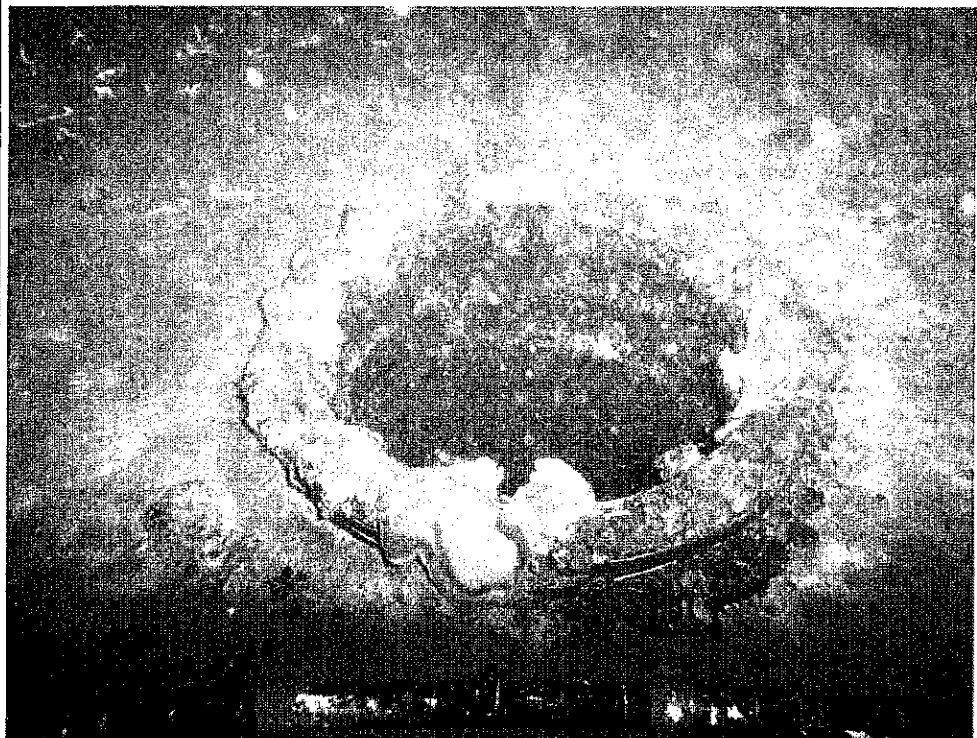
Image #28

Inlet 7:00

Condition:
Rust Grade¹ 1.

Description:
8" Inlet appeared to be in fair condition with a heavy amount of corrosion.

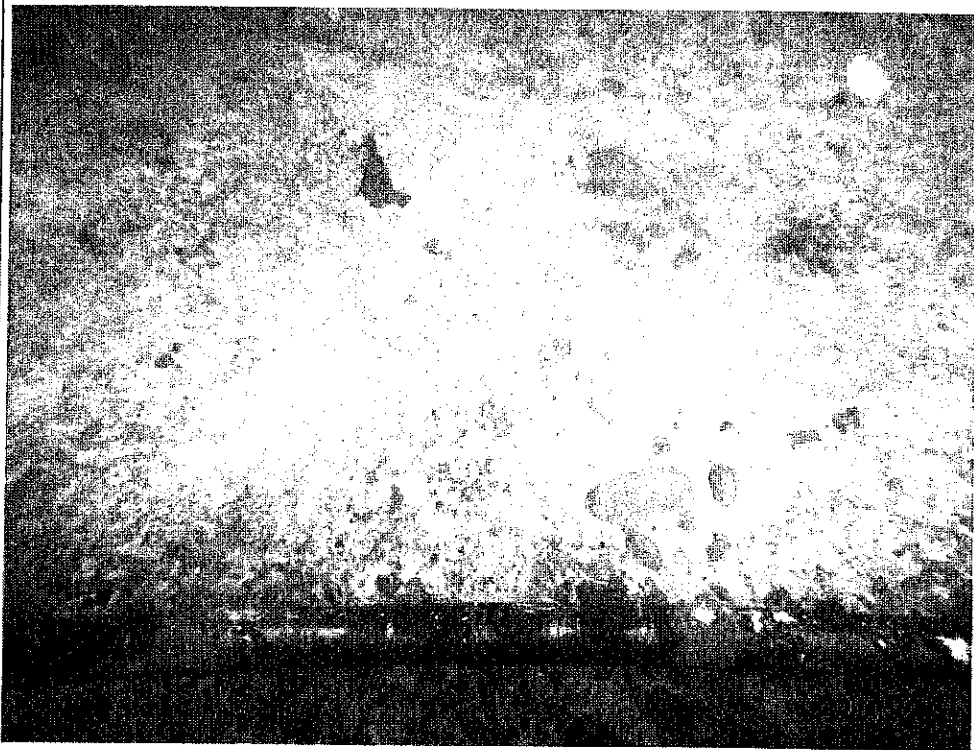
Image #29

Floor 9:00

Condition:
Concrete Deform³ GC

Description:
Floor appeared to be
in good condition with
no concrete problems.

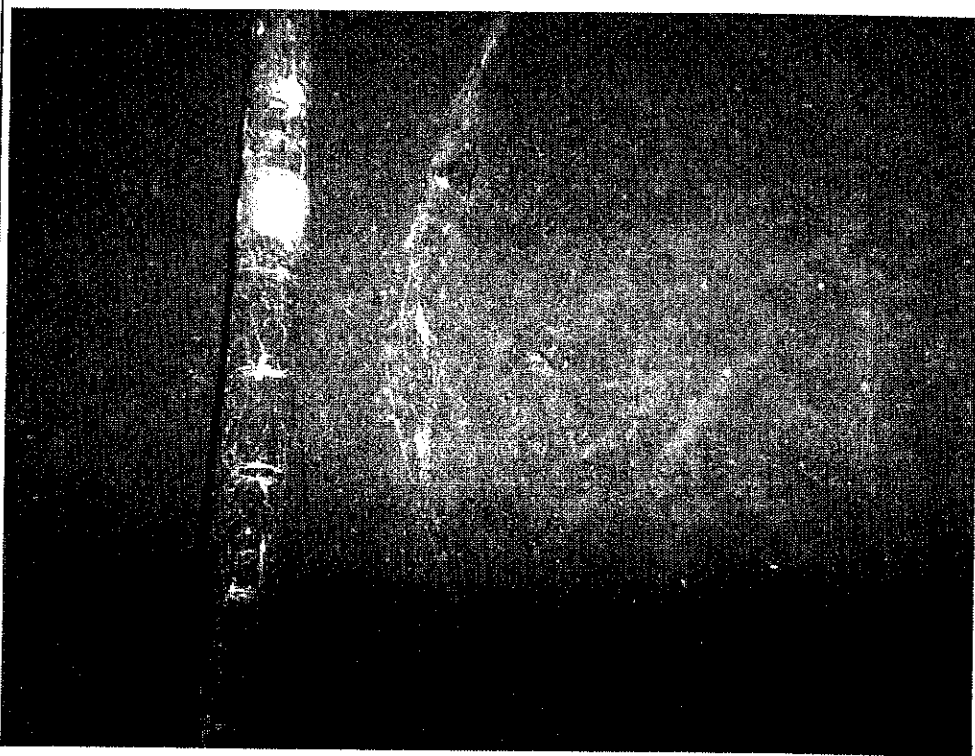
Image #30

Wall 9:00

Condition:
Concrete Deform³ CK,
PO

Description:
Wall appeared to be in
good condition with a
minor amount of
cracking and popouts.

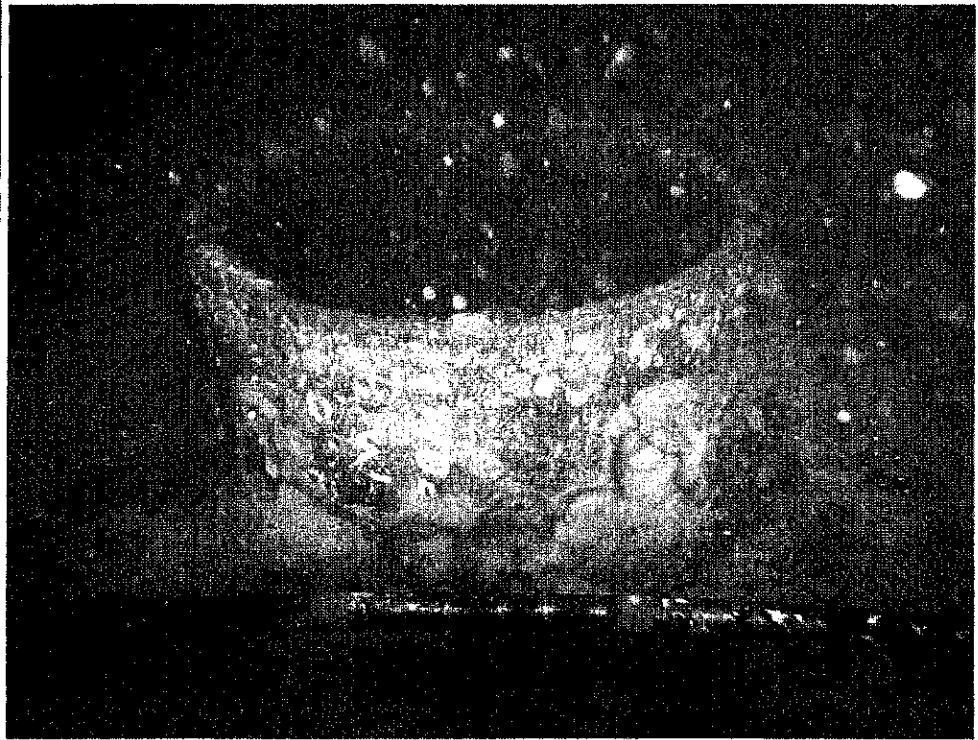
Image #31

Outlet 11:50

Condition:
Rust Grade¹ 2.

Description:
12" Outlet appeared to be in fair condition with a heavy amount of corrosion.

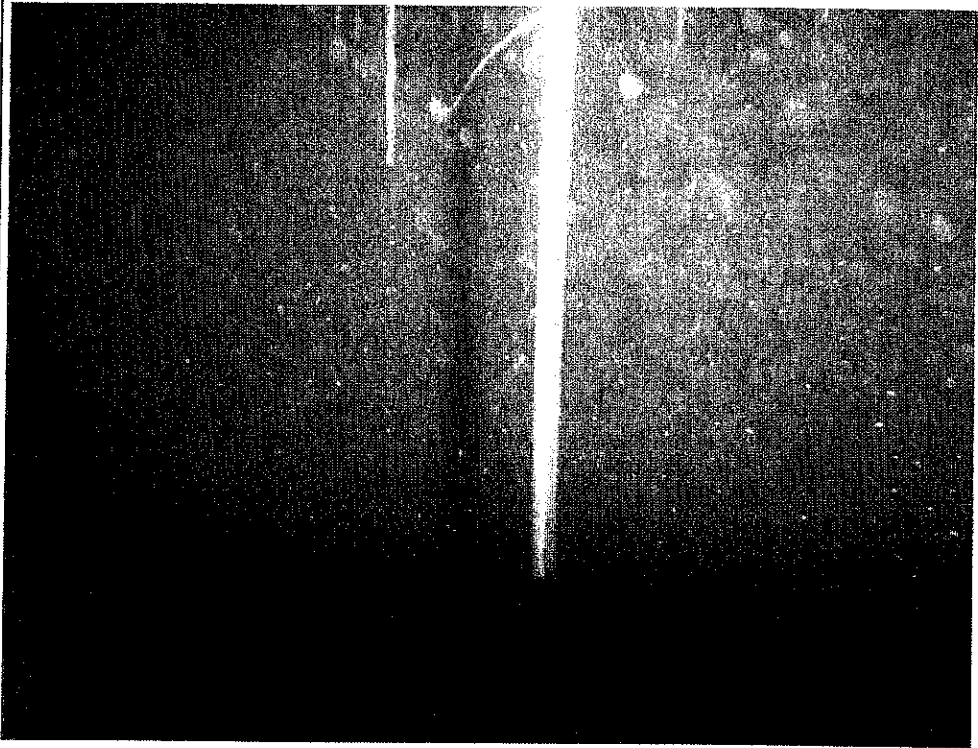
Image #33

Telemetry Line 11:55

Condition:
Rust Grade¹ 9.

Description:
Telemetry Line
appeared to be in good
condition with a minor
amount of corrosion.

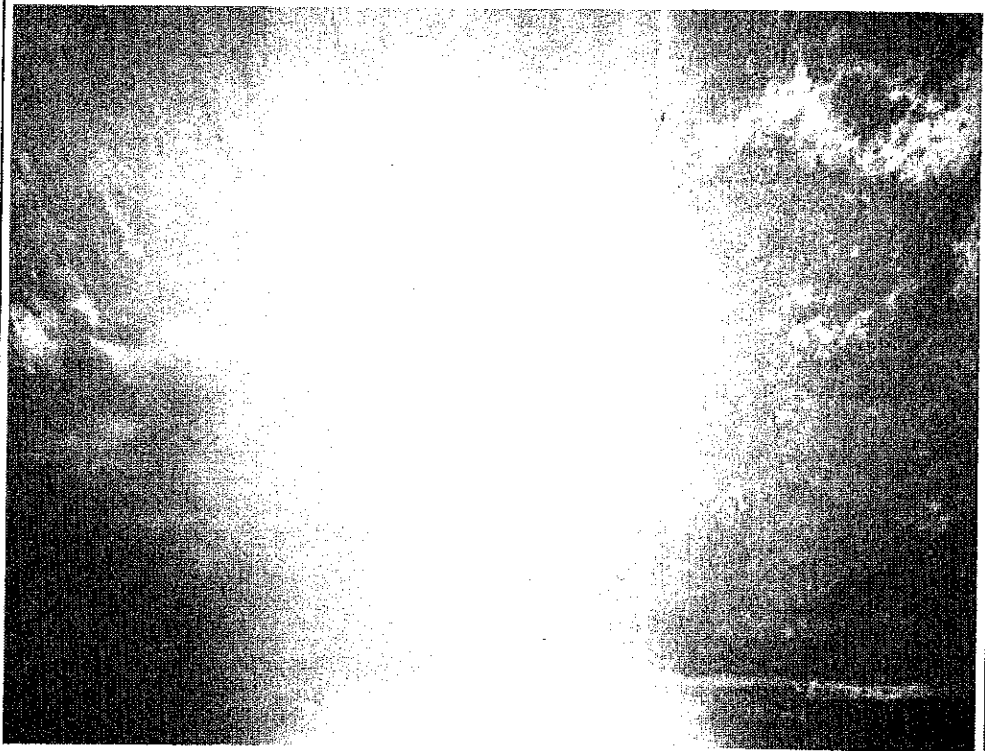
Image #34

Ceiling 12:00

Condition:
Concrete Deform³ CK.

Description:
Ceiling appeared to be
in fair condition with a
moderate amount of
cracking.

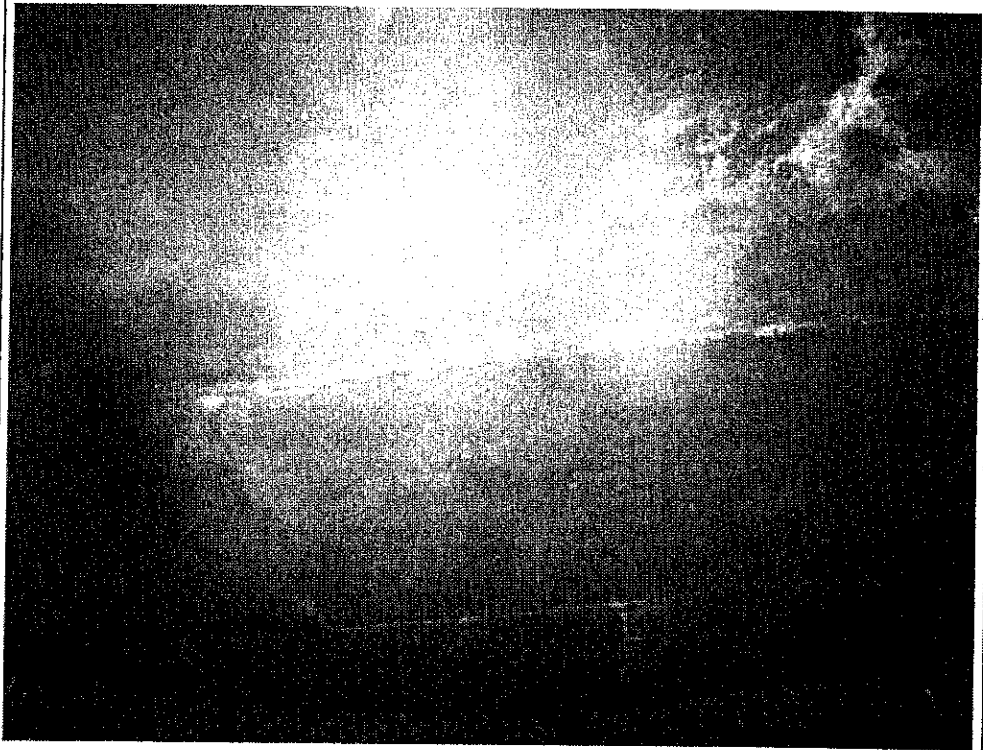
Image #37

Ceiling 9:00

Condition:
Concrete Deform³ CK

Description:
Ceiling appeared to be in fair condition with a moderate amount of cracking.
