WASHINGTON STATE DEPARTMENT OF HEALTH

Field Effectiveness of Ultraviolet Disinfection Units in On-site Sewage Treatment

Report to the US Environmental Protection Agency and the Washington State Department of Ecology

DOH 337-155 March 2025

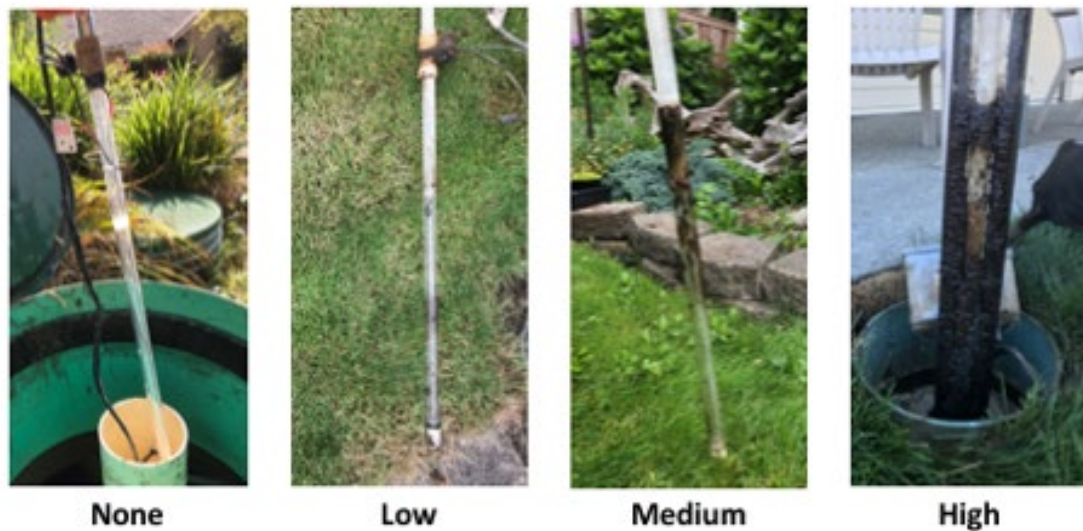
Figure 4. Rankings of Biofilm Deposit on UVD Unit Protective Sleeves

Biofilm buildup was present on 66% of the observed protective sleeves. Table 7 displays the proportion of UVD units with different biofilm levels. Five of the eight UVD units with a high biofilm deposit also had a UV bulb that was not glowing. In addition to biofilms, mineral deposits were present on many of the observed UVD units. However, these were generally thin, small, and located above the water level, so staff did not note when they were present.

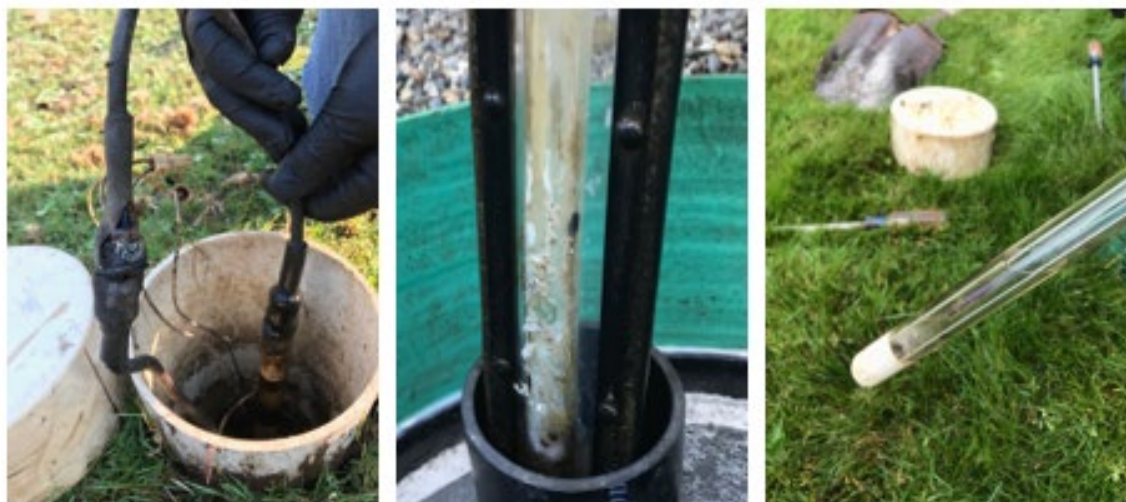
Of the observed OSSs, 14% had electrical damage. All but one were in Pierce County. Some of the UVD units had multiple types of electrical damage or corrosion, so a total of 22 issues were observed. Most often, the electrical wiring to the alarm sensor was corroded, charred, or loose, or the ballast was unprotected from water damage and corrosion. Few signs of burning or potential for electrical fires were observed. See Appendix A for details about electrical damage.

Figure 7. Examples of Common UVD Unit Issues. From left to right: electrical corrosion, torn Teflon sleeve, and water intrusion.

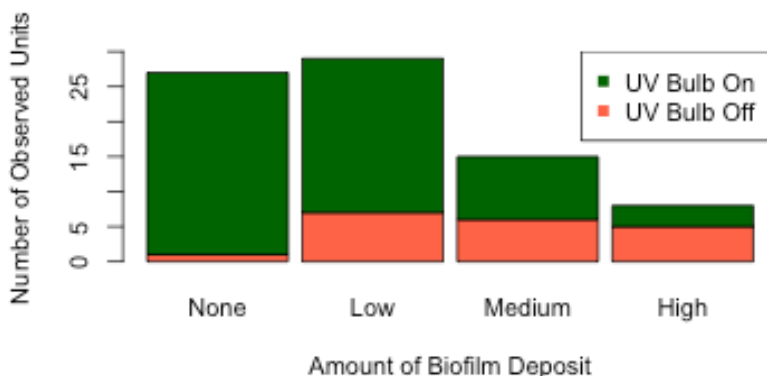
Based on an L1 regularized logistic regression model, the OSS issue that explained the most variability in UV bulb malfunction was the level of biofilm deposit. On average, the odds of UV bulb malfunction are 24% greater in UVD units that have a biofilm deposit that is higher by one ranking. On its own, differences in biofilm deposit explain 4% of the variability in UV bulb malfunction. Figure 8 displays the number of observed UVD units with biofilm deposits, and the proportion of each group that has a malfunctioning UV bulb.

Figure 8. UV Bulb Malfunction and Biofilm Deposit Levels in UVD Units
