Skagit County, WA

Human Bacteria Source Tracking with Scent-Trained Canine

May 28 and 29, 2014

Prepared by:
Environmental Canine Services LLC
130 Durham Road
Dover, NH 03820

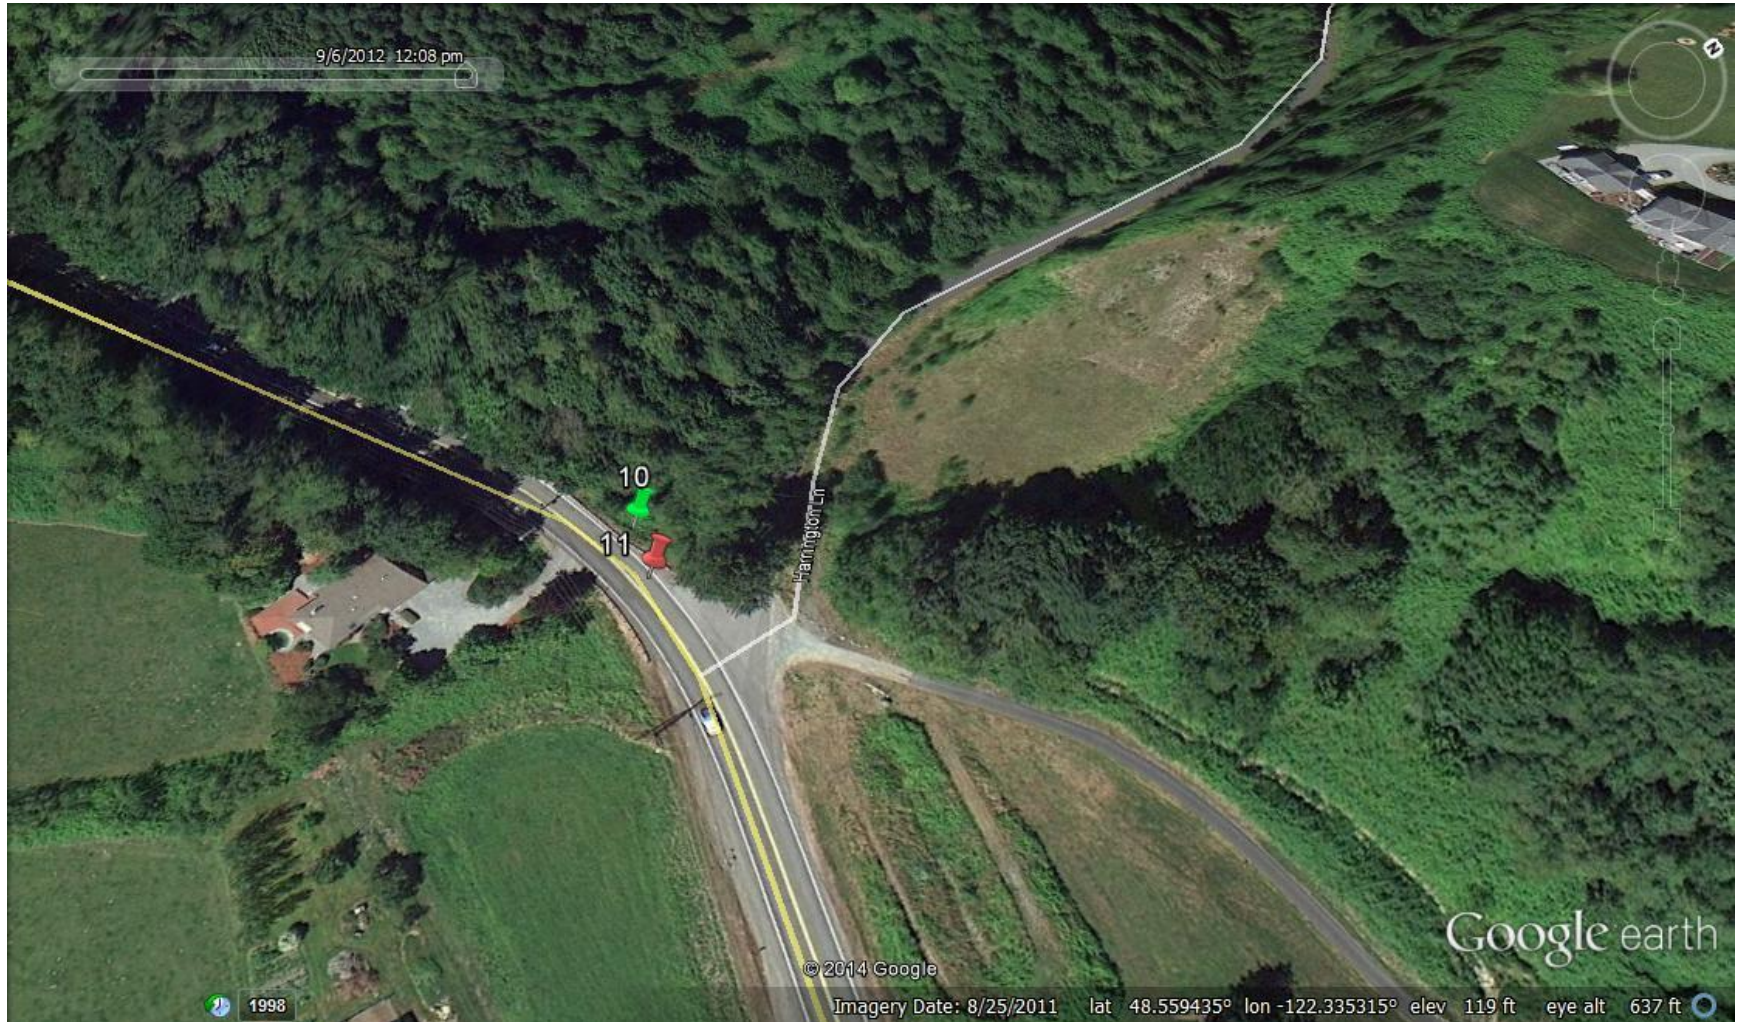
Sites 10-11

During the morning of May 29, ECS and Skagit County personnel conducted field investigations at various sites of interest in the watershed. Of particular interest was a re-investigation of the site at Bob Smith Creek near 5945 Bow Hill Road. Crush had alerted on a bucket sample from the site on the morning of May 28 but did not alert at the site during field investigations that afternoon. Upon reinvestigation of the site on the morning of May 29, Crush alerted. This may indicate an intermittent source of human fecal contamination at the site during morning hours.
