# Drinking Water Quality

**Mike Wolanek, City of Arlington  
Source Water Protection Workshop  
Tuesday, April 16, 2019**

# City of Arlington Stillaguamish Basin

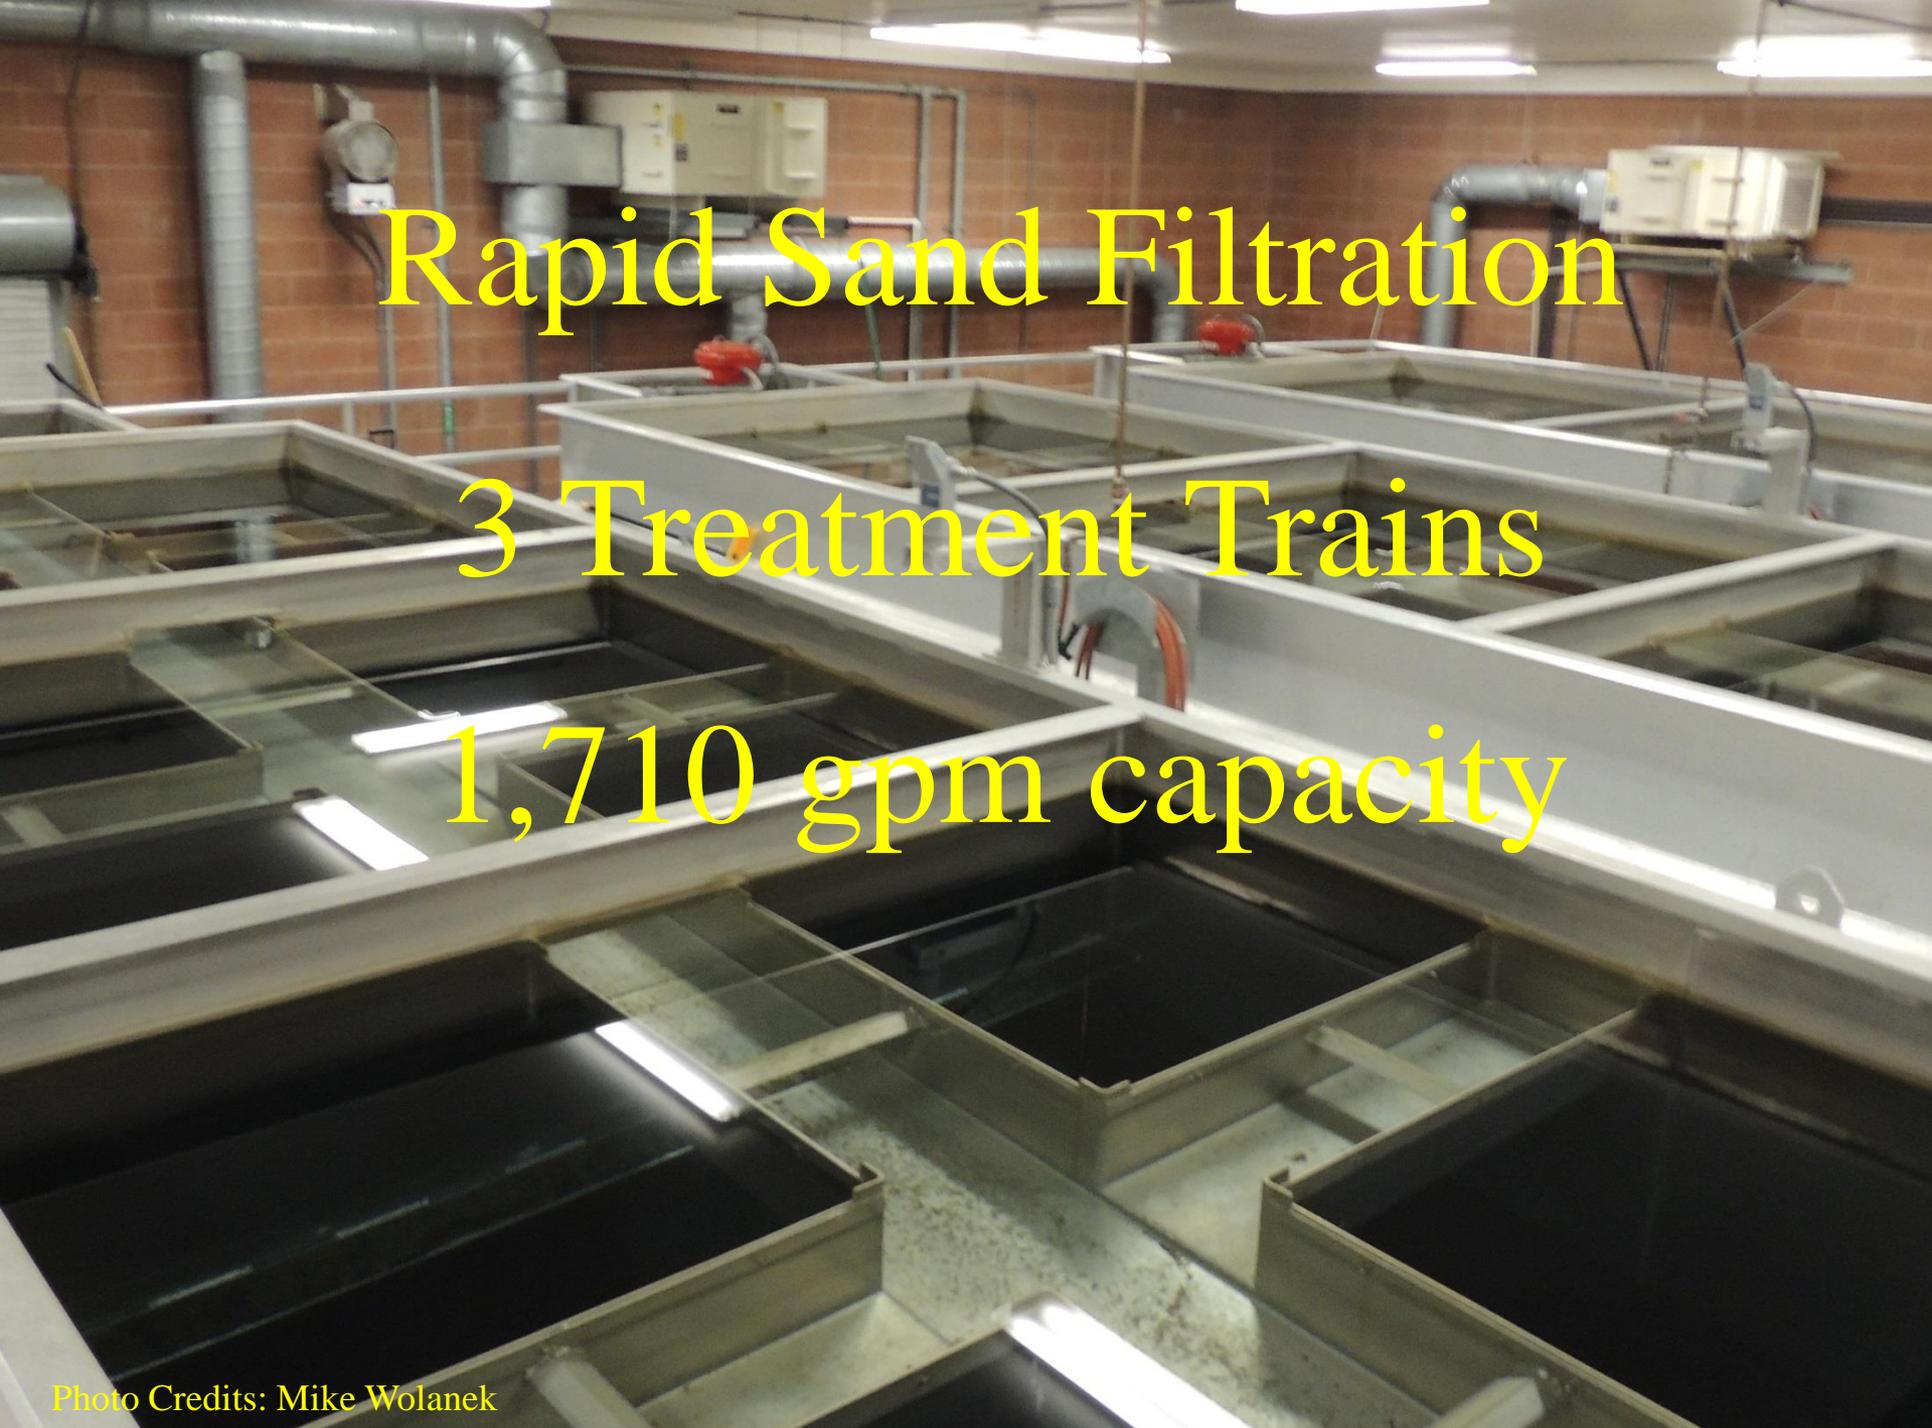
# Rapid Sand Filtration

The image shows a large industrial facility, likely a water treatment plant, with several rows of rectangular rapid sand filtration tanks. The tanks are arranged in a grid pattern and are filled with water. The background features brick walls, large pipes, and electrical control panels. The lighting is bright, coming from overhead fixtures.

3 Treatment Trains

1,710 gpm capacity

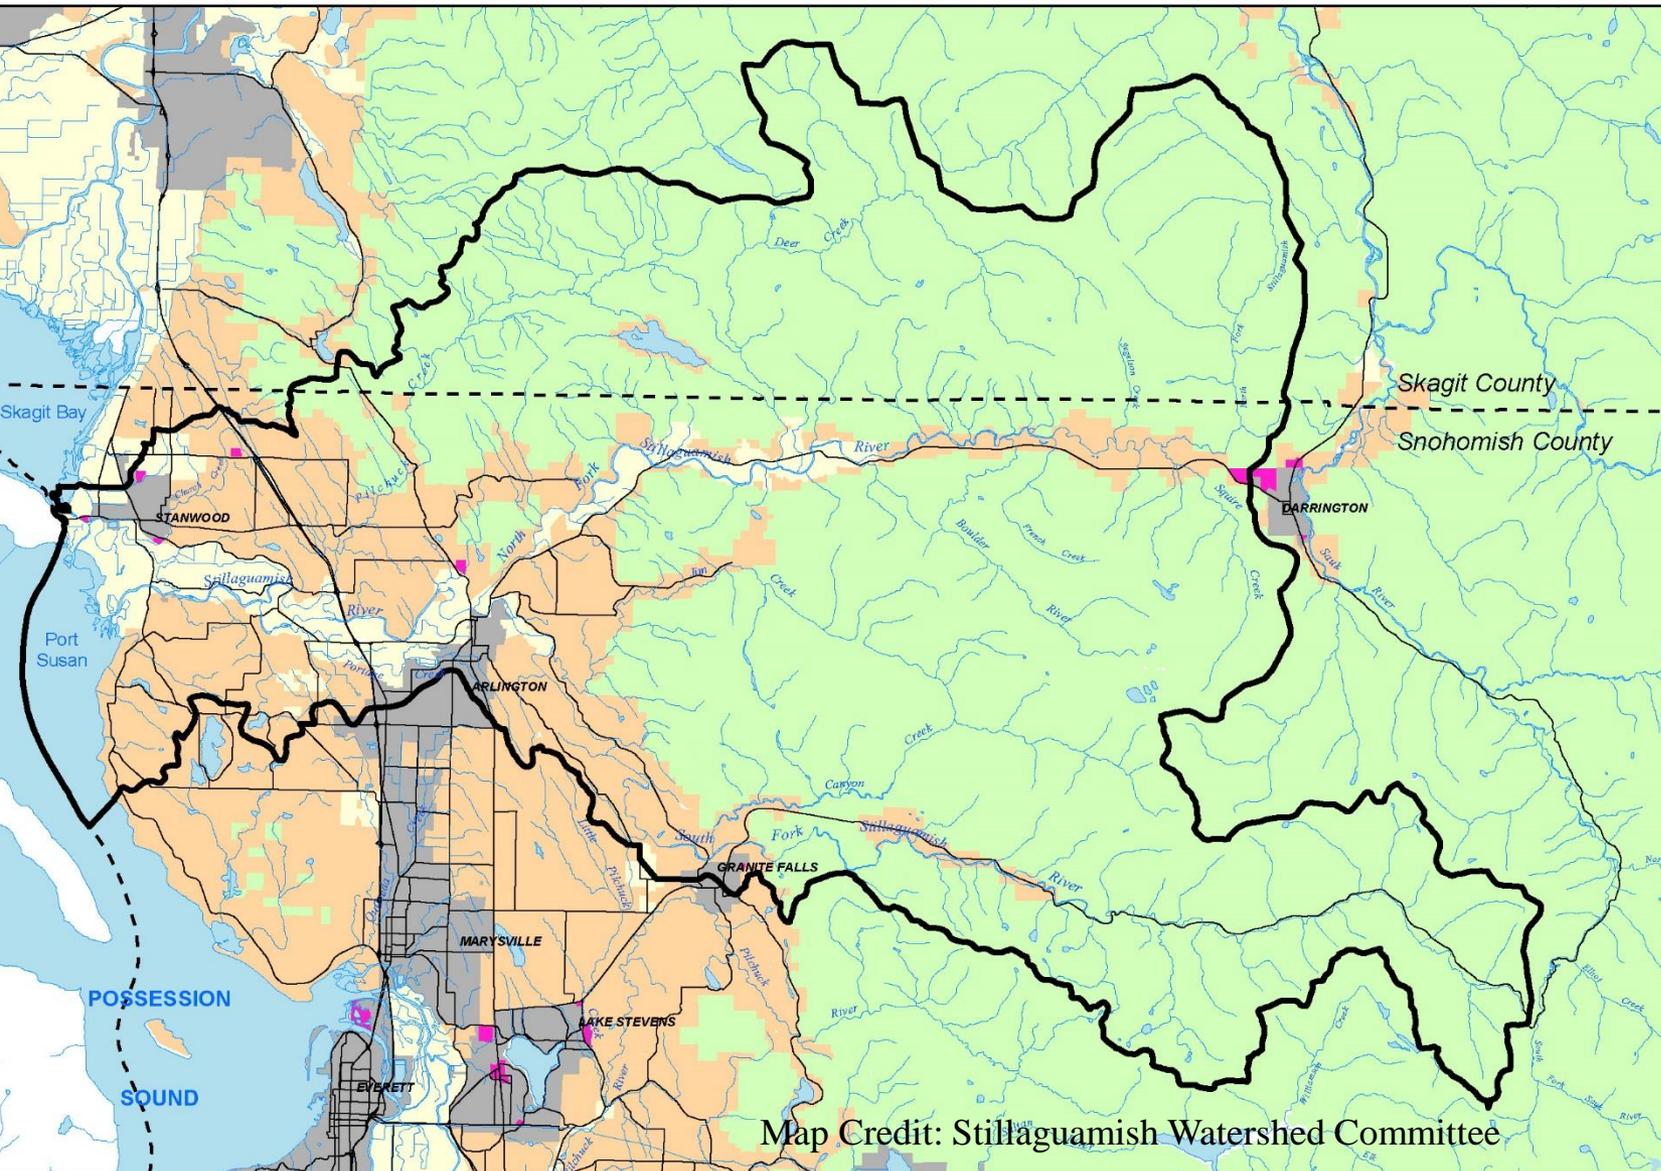
# Figure 4: Stillaguamish Watershed Future Land Use

\*Note: Land Use type derived from Snohomish & Skagit County Comprehensive Plans.

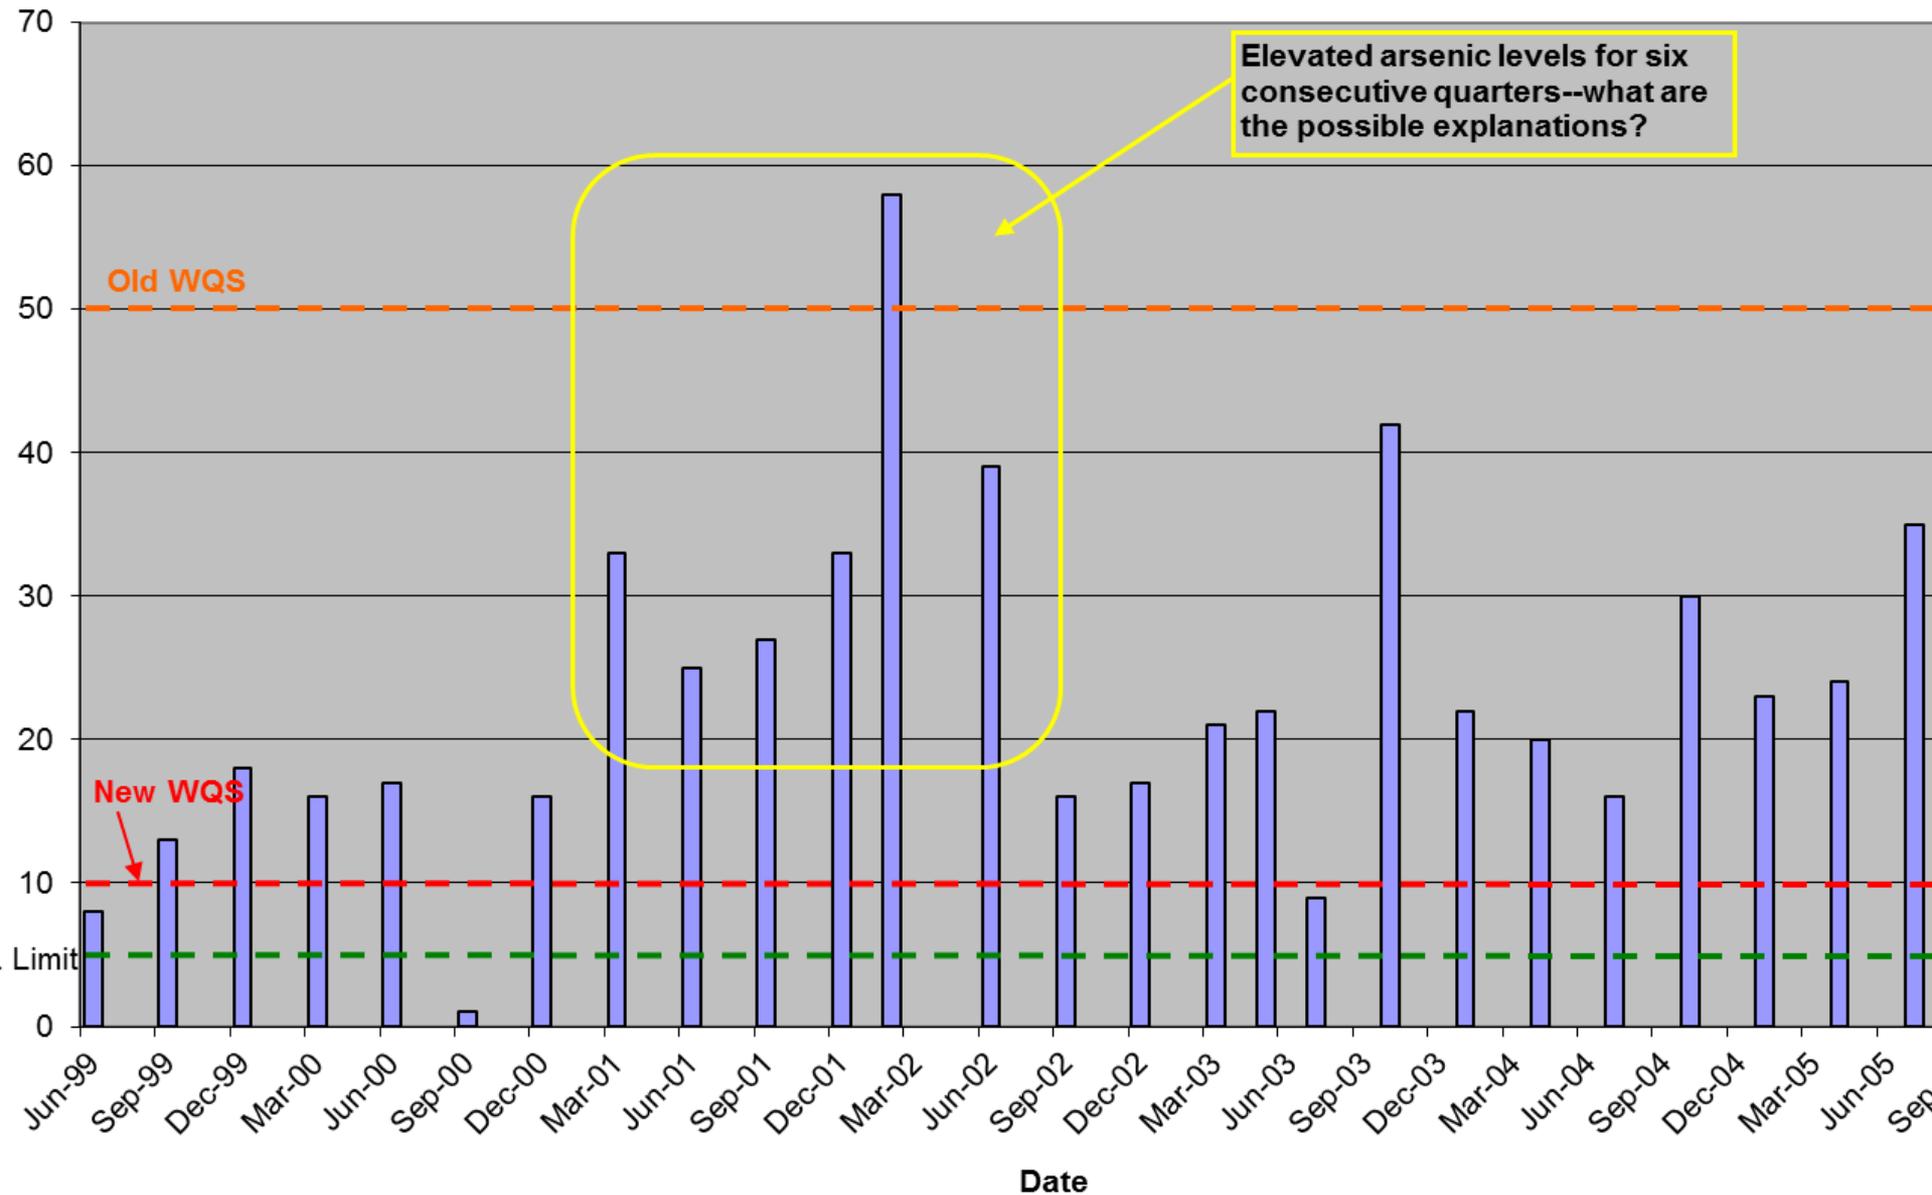
# Arsenic Levels in Rinker Monitoring Well 1A

(all other monitoring wells have arsenic below or near detection limits)

- 13 permitted in Stillaguamish basin
- Increased concern with lower arsenic standard
  - Track and comment on land use applications
  - Request monitoring reports
