## Appendix A: Additional Data Analysis

# Ultraviolet Disinfection in On-site Sewage Systems - Appendix A

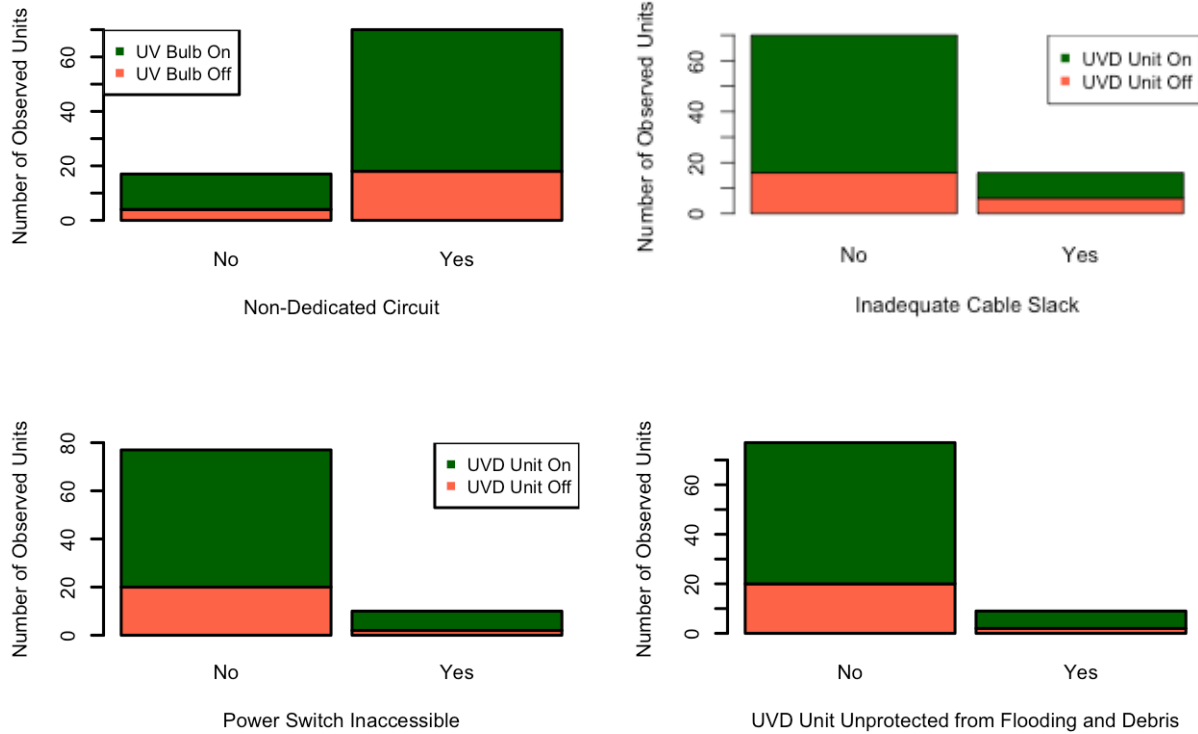
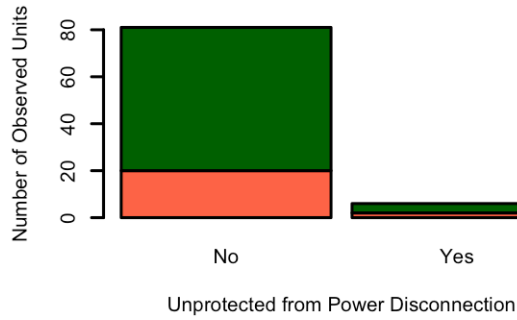
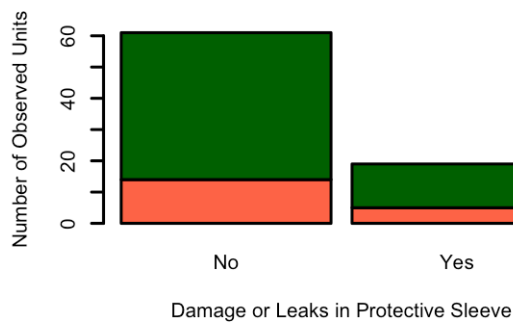
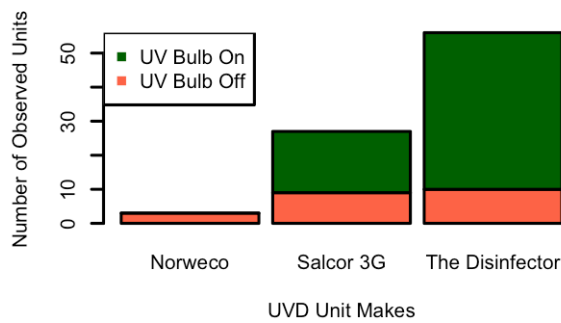
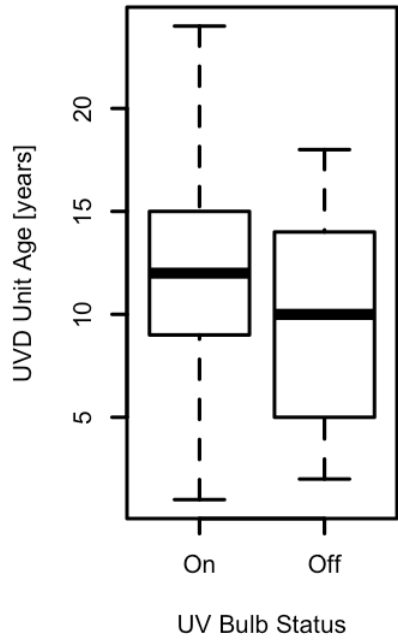
4. Plots Showing Proportion of UVD Units with UV Bulb Malfunction, Divided by Installation, Maintenance, and Current Functioning Characteristics

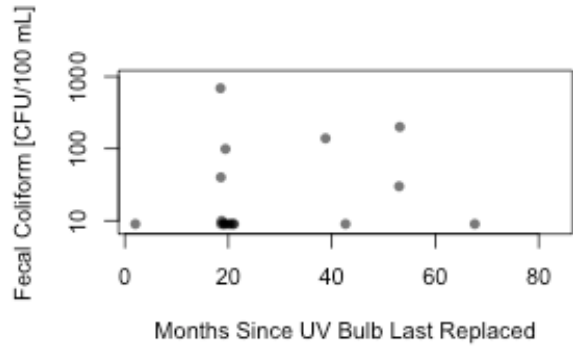
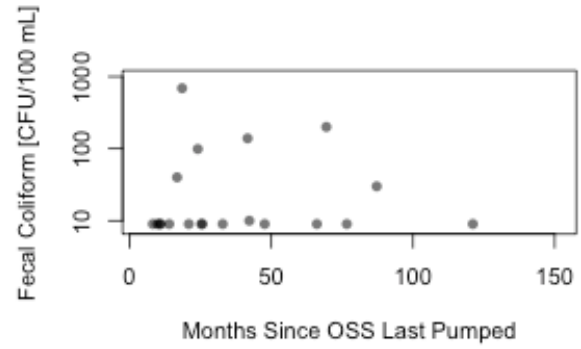
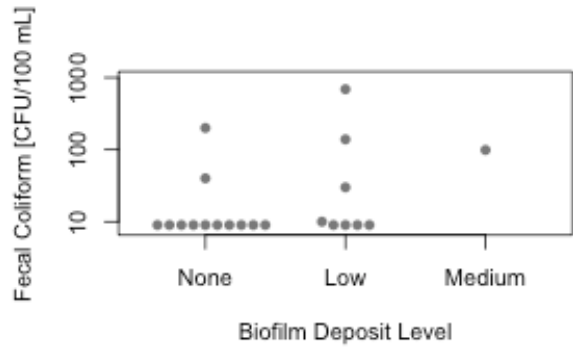
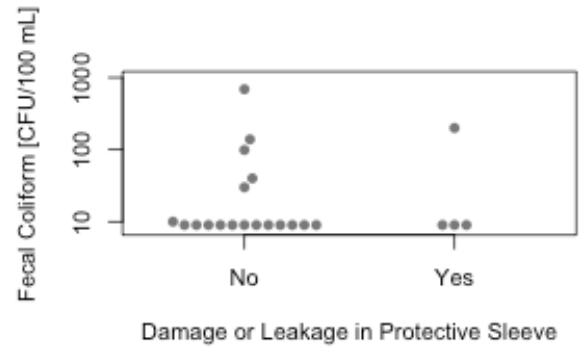
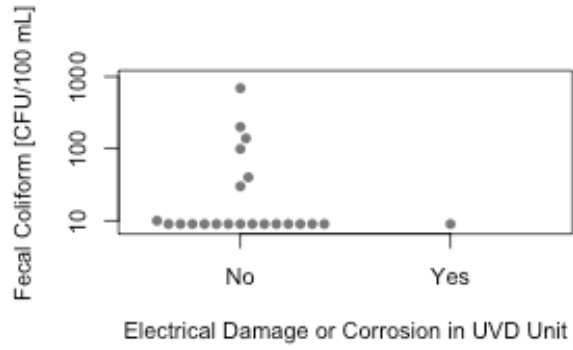
## 5. Plots of log-Transformed Post-UV Fecal Coliform Concentrations with UVD Units Divided by Installation, Maintenance, and Current Functioning Characteristics

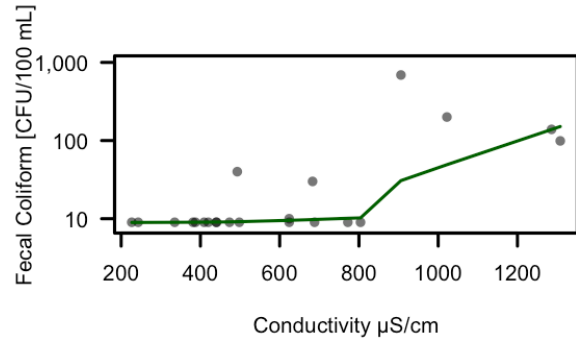
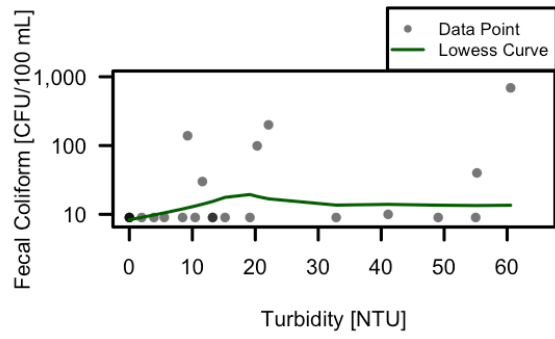
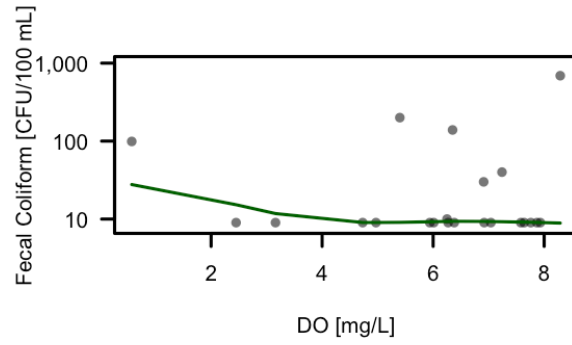
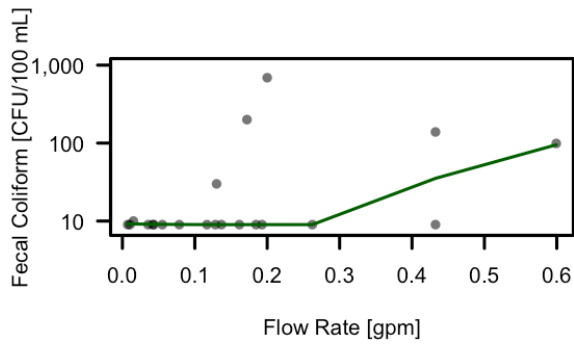
6. Scatterplots of Wastewater Quality Parameters as Predictors and log-Fecal Coliform Concentrations as Outcome
