Field Effectiveness of Ultraviolet Disinfection Units in On-site Sewage Treatment

Report to the US Environmental Protection Agency and the Washington State Department of Ecology

Washington State Department of Health
Office of Environmental Health and Safety
On-site Wastewater Management Section
March 2018

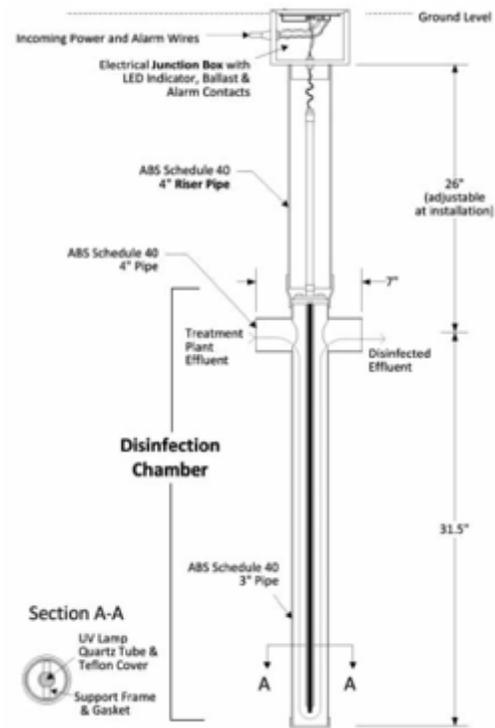
Figure 1. Schematic of UVD Unit (Source: Salcor, 2016)

The electrical components of the unit include a power cable connection, a UV bulb ballast, and alarm and sensor circuitry. Visual and/or audible alarms alert the user of low UV bulb intensity or UV bulb failure. Ideally, a waterproof case protects the electrical components of the unit (see Figure 1).

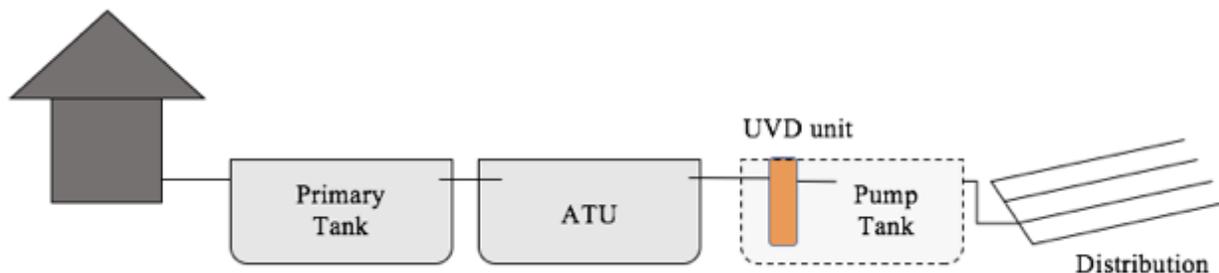
Figure 2. On-site Sewage System Components with UV Disinfection Unit

Ultraviolet disinfection units are registered for use with a variety of different treatment sequences. Most include a primary tank, an aerobic treatment unit (ATU), a UVD unit, and a soil dispersal component (see Figure 2).

Before sewage is disinfected, it must be treated in a pretreatment phase. Treatment usually begins in a septic tank, where solids, grease, oil, and some microorganisms are removed from the sewage. Most often, the septic tank is followed by an aerobic treatment unit (ATU), where aerobic bacteria break down organic matter and reduce pathogen levels. If properly managed, ATUs are able to reduce organic matter, solids, and bacterial load, as shown in Table 1 (US EPA, 2002). However, they often do not reduce fecal coliform levels below a 30-day geometric mean of 50,000 CFU/100 mL. Additional problems occur if ATUs are not properly maintained (US EPA, 2000). The ultraviolet disinfection unit, which is buried or placed within a chamber, receives the pretreated sewage and provides final disinfection of pathogens before the sewage is distributed.

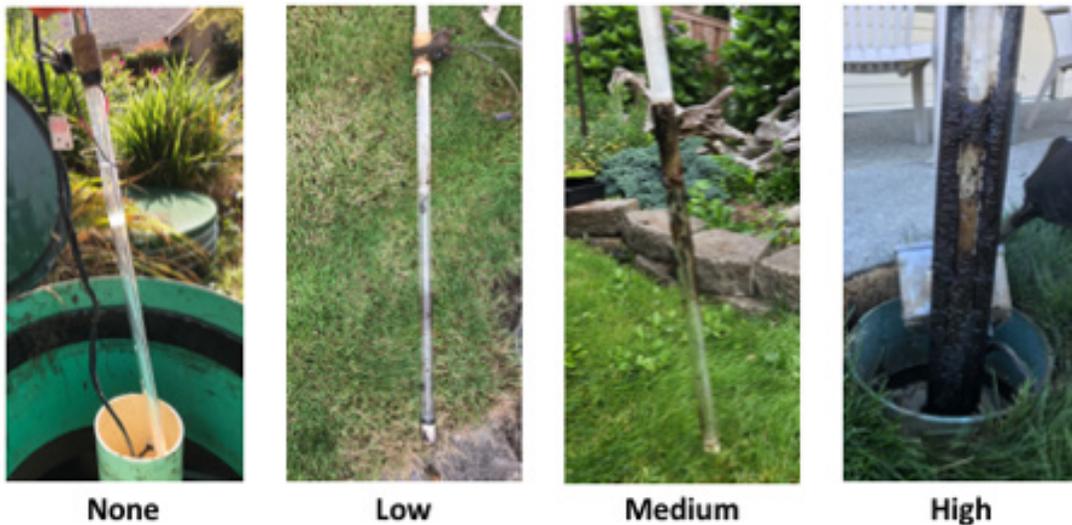
Figure 4. Rankings of Biofilm Deposit on UVD Unit Protective Sleeves

Biofilm buildup was present on 66% of the observed protective sleeves. Table 7 displays the proportion of UVD units with different biofilm levels. Five of the eight UVD units with a high biofilm deposit also had a UV bulb that was not glowing. In addition to biofilms, mineral deposits were present on many of the observed UVD units. However, these were generally thin, small, and located above the water level, so staff did not note when they were present.

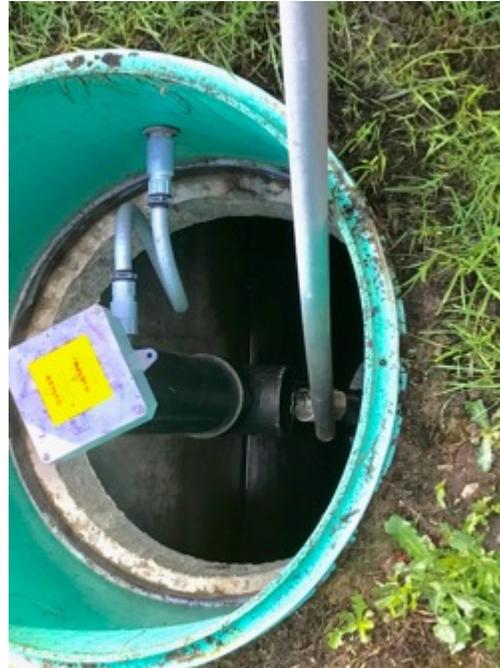
Figure 5. Sampling of Freefall UVD Unit Effluent

The flow rate was characterized by measuring the length of time needed to fill a 100 mL bottle with the free-flowing UVD unit effluent.

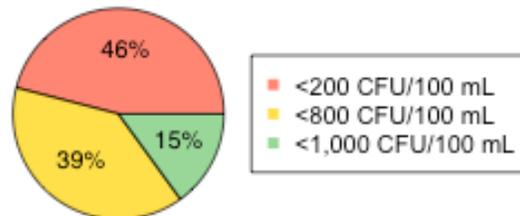
Figure 6. Treatment Level Standards of Thurston County UVD Units

In Thurston County, 53% of the OSSs with UVD units are designed to meet either Treatment Level B or Treatment Level 2 (see Figure 6). In the study sample, the OSS with effluent that exceeded 400 CFU/100 mL was designed for Treatment Level B. The 0-14% of UVD units with effluent that may exceed 400 CFU/100 mL at any given time are likely to be OSSs where Treatment Level designations allow for higher effluent FC levels.

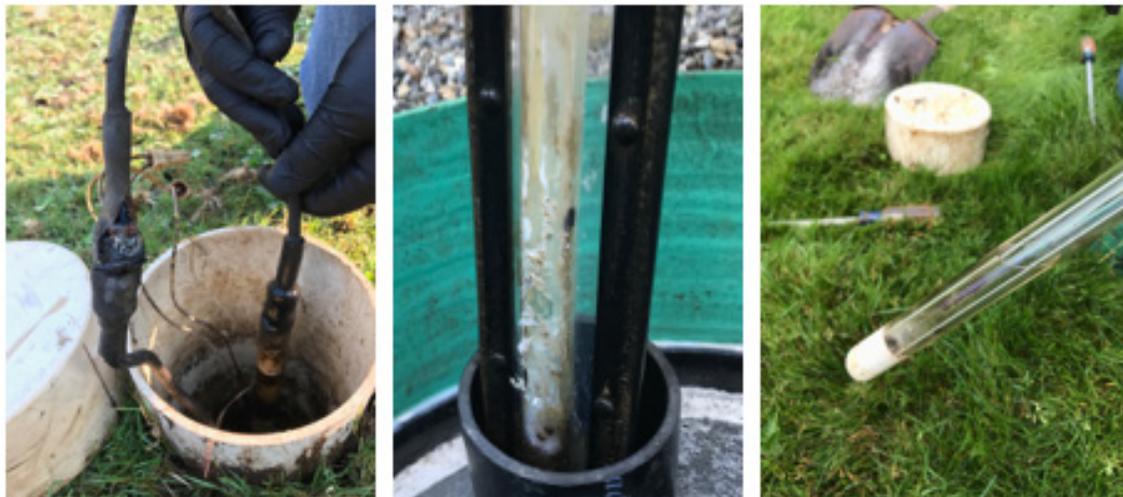
Figure 7. Examples of Common UVD Unit Issues. From left to right: electrical corrosion, torn Teflon sleeve, and water intrusion.

Of the observed OSSs, 14% had electrical damage. All but one were in Pierce County. Some of the UVD units had multiple types of electrical damage or corrosion, so a total of 22 issues were observed. Most often, the electrical wiring to the alarm sensor was corroded, charred, or loose, or the ballast was unprotected from water damage and corrosion. Few signs of burning or potential for electrical fires were observed. See Appendix A for details about electrical damage.

While 14% of the observed UVD units had electrical damage, few presented a direct risk to the safety of OSS owners or maintenance providers. Contact with some of the systems could lead to a risk of electrical shock, but few introduced a risk of fires or other significant damage. The larger concern is the proportion of units that are not disinfecting sewage effluent, as these may discharge sewage with high pathogen loads.

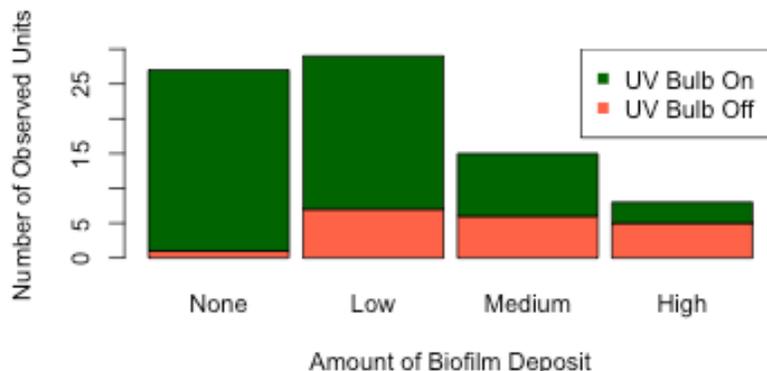
Figure 8. UV Bulb Malfunction and Biofilm Deposit Levels in UVD Units

The issues that were most strongly associated with UV bulb malfunction were electrical corrosion or damage and amount of biofilm deposit.

Based on an L1 regularized logistic regression model, the OSS issue that explained the most variability in UV bulb malfunction was the level of biofilm deposit. On average, the odds of UV bulb malfunction are 24% greater in UVD units that have a biofilm deposit that is higher by one ranking. On its own, differences in biofilm deposit explain 4% of the variability in UV bulb malfunction. Figure 8 displays the number of observed UVD units with biofilm deposits, and the proportion of each group that has a malfunctioning UV bulb.
